Release Notes for Cisco Aironet 350, 1100, 1130AG, 1200, and 1230AG Series Access Points for Cisco IOS Release 12.3(2)JA6

April 3, 2006

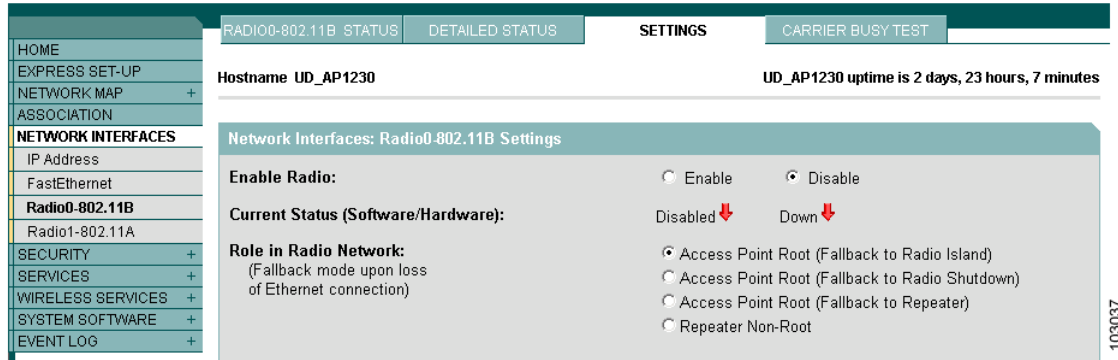
Figure 1 Network Interfaces: Radio Settings Page

If your access point runs Cisco IOS Release 12.2(11)JA, 12.2(11)JA1, or 12.2(11)JA2, your access point might unexpectedly reboot after you upgrade to a later Cisco IOS Release. Because of a rare timing condition that affects the radios, the access point sometimes reboots immediately after the upgrade when

the radios are enabled. However, after the access point reboots the upgrade is complete and the access point operates normally. To prevent the access point from rebooting unexpectedly, disable the radio interfaces before upgrading software.

Follow these steps to disable the radio interfaces using the web-browser interface:

- Step 1** Browse to the Network Interfaces: Radio Settings page. shows the top portion of the Network Interfaces: Radio Settings page.

- Step 2** Select **Disable** to disable the radio.
- Step 3** Click **Apply** at the bottom of the page.
- Step 4** If your access point has two radios, repeat these steps for the second radio.

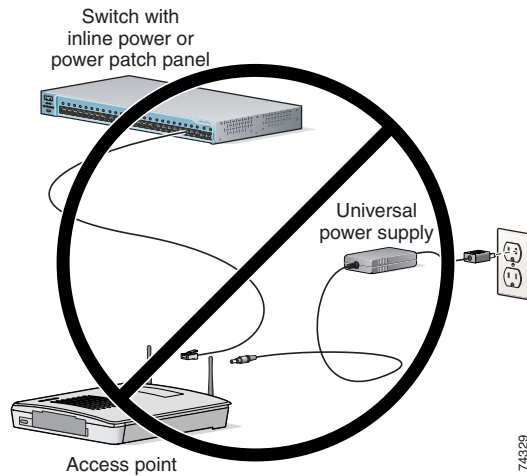
Figure 2 *Improper Power Configuration Using Two Power Sources*

You cannot provide redundant power to 1100, 1130, and 1200 series access points with both DC power to its power port and inline power from a patch panel or powered switch to the access point's Ethernet port. If you apply power to the access point from both sources, the switch or power patch panel might shut down the port to which the access point is connected. [Figure 2](#) shows the power configuration that can shut down the port on the patch panel or powered switch.
