Release Notes for Cisco Aironet 350, 1100, 1130AG, 1200, and 1230AG Series Access Points for Cisco IOS Release 12.3(4)JA1

September 12, 2005

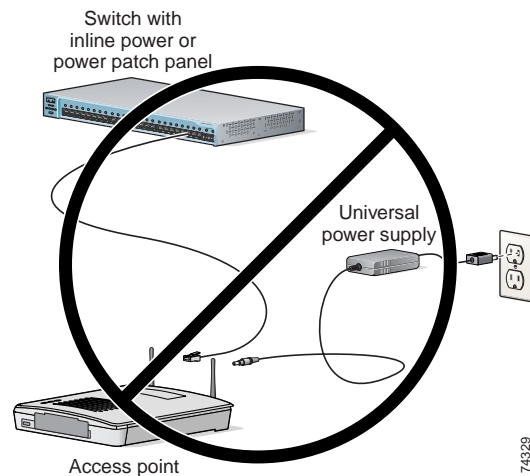
Figure 2 Improper Power Configuration Using Two Power Sources

You cannot provide redundant power to 1100, 1130, and 1200 series access points with both DC power to its power port and inline power from a patch panel or powered switch to the access point's Ethernet port. If you apply power to the access point from both sources, the switch or power patch panel might shut down the port to which the access point is connected. [Figure 2](#) shows the power configuration that can shut down the port on the patch panel or powered switch.
