# Release Notes for Cisco Aironet 350, 1100, 1130AG, 1200 and 1230AG Series Access Points for Cisco IOS Release 12.3(4)JA2

April 3, 2006

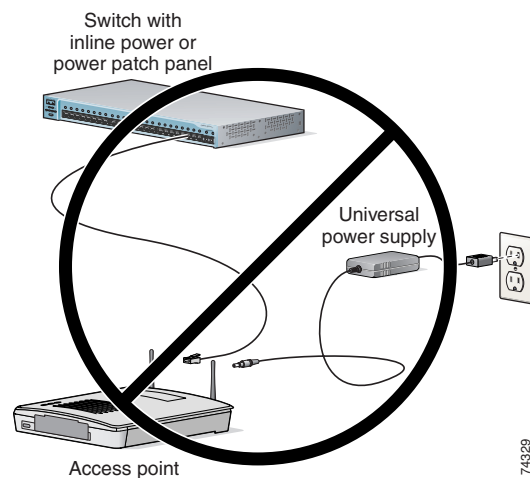
**Figure 2** *Improper Power Configuration Using Two Power Sources*

You cannot provide redundant power to 1100, 1130, and 1200 series access points with both DC power to its power port and inline power from a patch panel or powered switch to the access point's Ethernet port. If you apply power to the access point from both sources, the switch or power patch panel might shut down the port to which the access point is connected. [Figure 2](#) shows the power configuration that can shut down the port on the patch panel or powered switch.
