Release Notes for Cisco Aironet Access Points for Cisco IOS Release 12.3(7)JA1

October 18, 2005

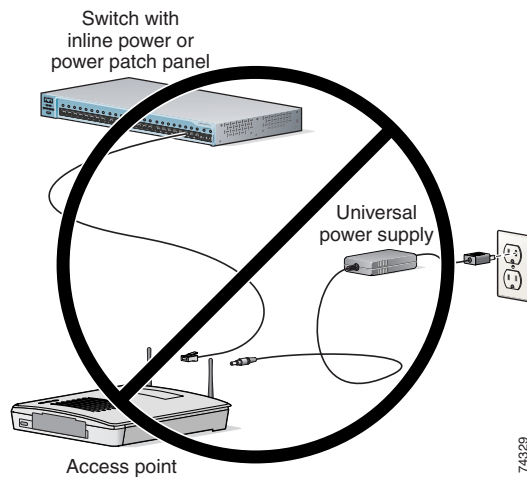
Figure 2 *Improper Power Configuration Using Two Power Sources*

You cannot provide redundant power to 1100, 1130AG, and 1200 series access points with both DC power to its power port and inline power from a patch panel or powered switch to the access point's Ethernet port. If you apply power to the access point from both sources, the switch or power patch panel might shut down the port to which the access point is connected. [Figure 2](#) shows the power configuration that can shut down the port on the patch panel or powered switch.
