Release Notes for Cisco Aironet Access Points for Cisco IOS Release 12.3(7)JA4

September 6, 2006

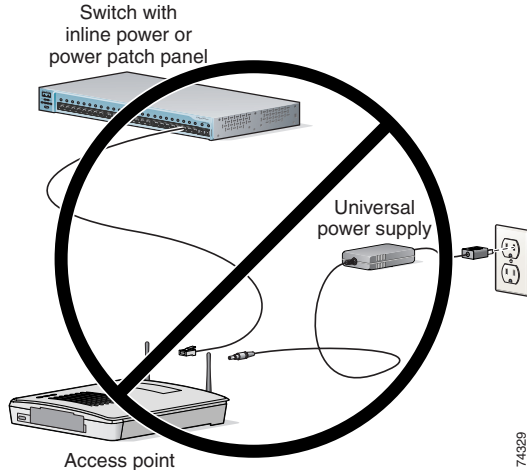
Figure 2 *Improper Power Configuration Using Two Power Sources*

You cannot provide redundant power to 1100, 1130AG, and 1200 series access points with both DC power to its power port and inline power from a patch panel or powered switch to the access point's Ethernet port. If you apply power to the access point from both sources, the switch or power patch panel might shut down the port to which the access point is connected. [Figure 2](#) shows the power configuration that can shut down the port on the patch panel or powered switch.
