Release Notes for Cisco Aironet Access Points for Cisco IOS Release 12.3(7)JA

August 15, 2005

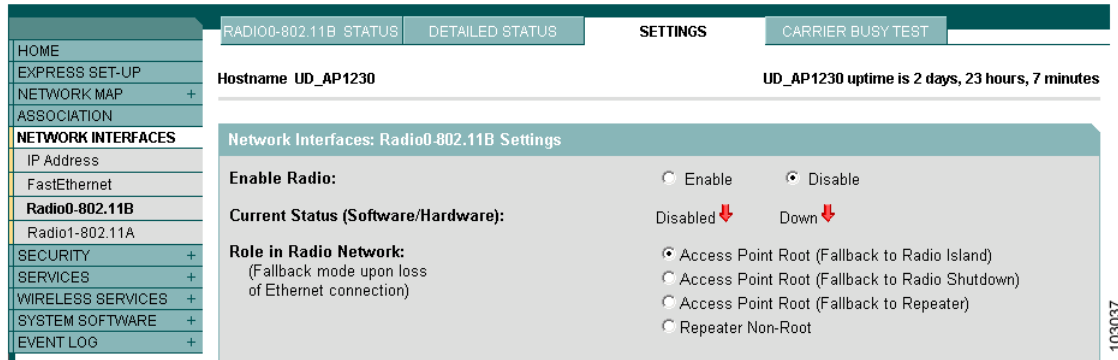
Figure 1 Network Interfaces: Radio Settings Page

If your access point runs Cisco IOS Release 12.2(11)JA, 12.2(11)JA1, or 12.2(11)JA2, your access point might unexpectedly reboot after you upgrade to a later Cisco IOS Release. Because of a rare timing condition that affects the radios, the access point sometimes reboots immediately after the upgrade when the radios are enabled. However, after the access point reboots the upgrade is complete and the access point operates normally. To prevent the access point from rebooting unexpectedly, disable the radio interfaces before upgrading software.

- Step 1** Browse to the Network Interfaces: Radio Settings page. [Figure 1](#) shows the top portion of the Network Interfaces: Radio Settings page.

- Step 2** Select **Disable** to disable the radio.
- Step 3** Click **Apply** at the bottom of the page.
- Step 4** If your access point has two radios, repeat these steps for the second radio.

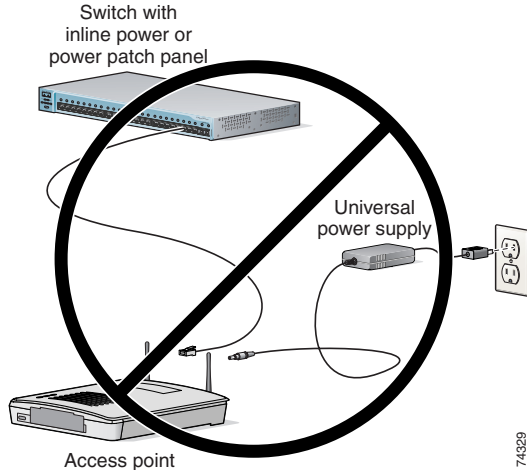
Figure 2 *Improper Power Configuration Using Two Power Sources*

You cannot provide redundant power to 1100, 1130AG, and 1200 series access points with both DC power to its power port and inline power from a patch panel or powered switch to the access point's Ethernet port. If you apply power to the access point from both sources, the switch or power patch panel might shut down the port to which the access point is connected. [Figure 2](#) shows the power configuration that can shut down the port on the patch panel or powered switch.
