Release Notes for Cisco Aironet Access Points for Cisco IOS Release 12.3(8)JA

March 3, 2006 OL-8237-01

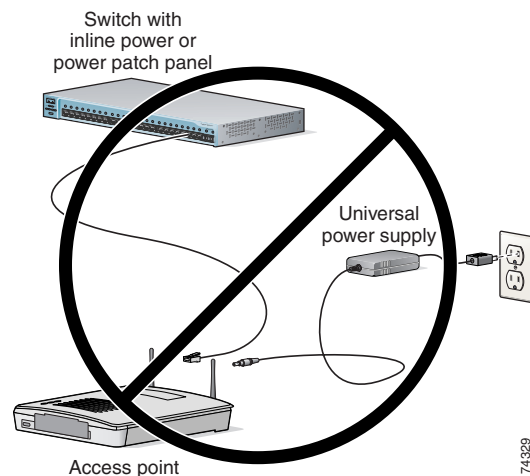
Figure 2 *Improper Power Configuration Using Two Power Sources*

You cannot provide redundant power to 1100, 1130AG, and 1200 series access points with both DC power to its power port and inline power from a patch panel or powered switch to the access point's Ethernet port. If you apply power to the access point from both sources, the switch or power patch panel might shut down the port to which the access point is connected. [Figure 2](#) shows the power configuration that can shut down the port on the patch panel or powered switch.
