# Release Notes for Cisco Aironet Access Points for Cisco IOS Release 12.3(8)JEB

April 26, 2007

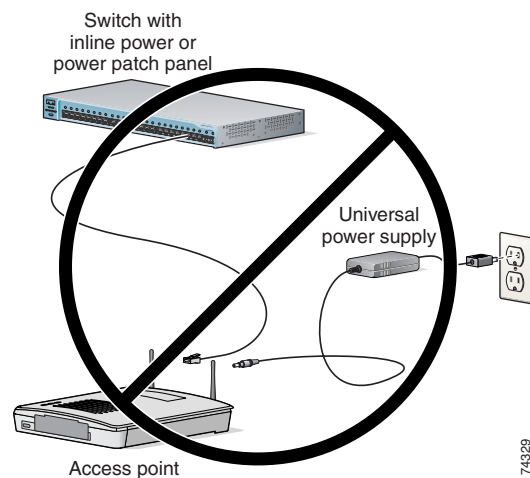
**Figure 2** *Improper Power Configuration Using Two Power Sources*

You cannot provide redundant power to 1100 and 1200 series access points with both DC power to its power port and inline power from a patch panel or powered switch to the access point's Ethernet port. If you apply power to the access point from both sources, the switch or power patch panel might shut down the port to which the access point is connected. [Figure 2](#) shows the power configuration that can shut down the port on the patch panel or powered switch.
