Release Notes for Cisco Aironet 350, 1100, and 1200 Series Access Points for Cisco IOS Release 12.2(13)JA2

February 5, 2004

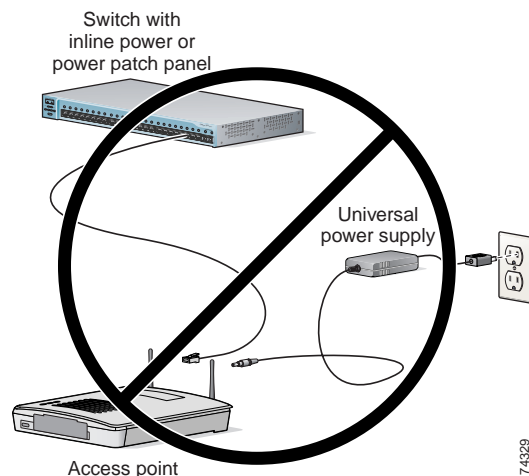
Figure 1 Improper Power Configuration Using Two Power Sources

You cannot provide redundant power to 1100 and 1200 series access points with both DC power to its power port and inline power from a patch panel or powered switch to the access point's Ethernet port. If you apply power to the access point from both sources, the switch or power patch panel might shut down the port to which the access point is connected. [Figure 1](#) shows the power configuration that can shut down the port on the patch panel or powered switch.
