Release Notes for Cisco Aironet 1100 and 1200 Series Access Points for Cisco IOS Release 12.2(13)JA3

February 26, 2004

Cisco IOS Release 12.2(13)JA3 resolves caveat CSCed50731, but does not introduce new features. These release notes describe caveats for Cisco IOS Release 12.2(13)JA3 and features and enhancements introduced in Cisco IOS Release 12.2(13)JA. They also provide important information about Cisco Aironet 1100 and 1200 Series Access Points.

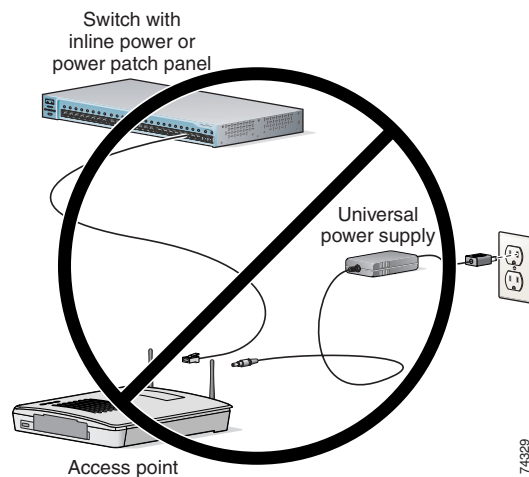
Figure 1 *Improper Power Configuration Using Two Power Sources*

You cannot provide redundant power to 1100 and 1200 series access points with both DC power to its power port and inline power from a patch panel or powered switch to the access point's Ethernet port. If you apply power to the access point from both sources, the switch or power patch panel might shut down the port to which the access point is connected. [Figure 1](#) shows the power configuration that can shut down the port on the patch panel or powered switch.

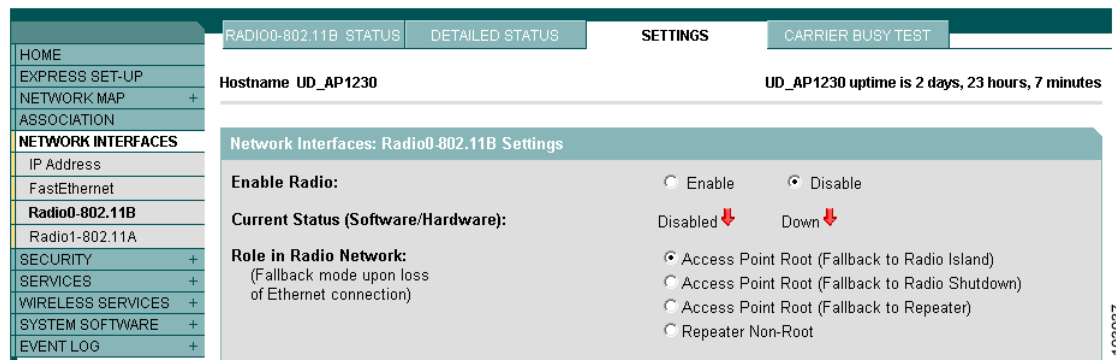
Figure 2 Network Interfaces: Radio Settings Page

If your access point runs Cisco IOS Release 12.2(11)JA or 12.2(11)JA1 the access point might reboot immediately after you upgrade to Cisco IOS Release 12.2(13)JA3. Because of a rare timing condition that affects the radios, the access point sometimes reboots immediately after the upgrade when the radios are enabled. However, when the access point reboots after the crash, the upgrade is complete and the access point operates normally. To prevent the access point from rebooting unexpectedly, disable the radio interfaces before upgrading to Cisco IOS Release 12.2(13)JA3.

- Step 1** Browse to the Network Interfaces: Radio Settings page. [Figure 2](#) shows the top portion of the Network Interfaces: Radio Settings page.

- Step 2** Click **Disable** to disable the radio.
- Step 3** Click **Apply** at the bottom of the page.
- Step 4** If your access point has two radios, repeat these steps for the second radio.
