Release Notes for Cisco Aironet 1100 and 1200 Series Access Points for Cisco IOS Release 12.2(13)JA3

February 26, 2004

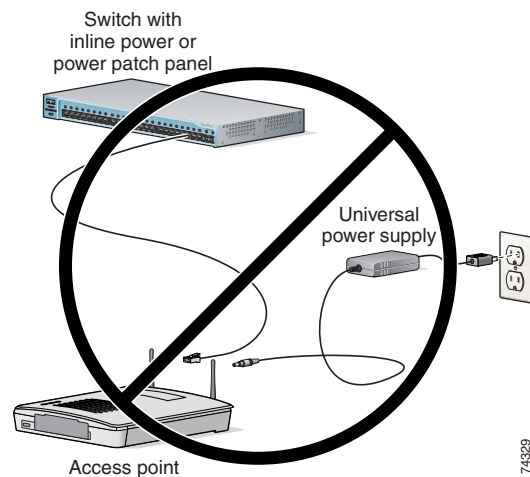
Figure 1 *Improper Power Configuration Using Two Power Sources*

You cannot provide redundant power to 1100 and 1200 series access points with both DC power to its power port and inline power from a patch panel or powered switch to the access point's Ethernet port. If you apply power to the access point from both sources, the switch or power patch panel might shut down the port to which the access point is connected. [Figure 1](#) shows the power configuration that can shut down the port on the patch panel or powered switch.
