# Release Notes for Cisco Aironet 350, 1100, and 1200 Series Access Points for Cisco IOS Release 12.2(13)JA4

April 19, 2004

Cisco IOS Release 12.2(13)JA4 resolves caveats CSCdz32659, CSCed27956, CSCed38527, and CSCed40563 but does not introduce new features. These release notes describe caveats for Cisco IOS Release 12.2(13)JA4 and features and enhancements introduced in Cisco IOS Release 12.2(13)JA.

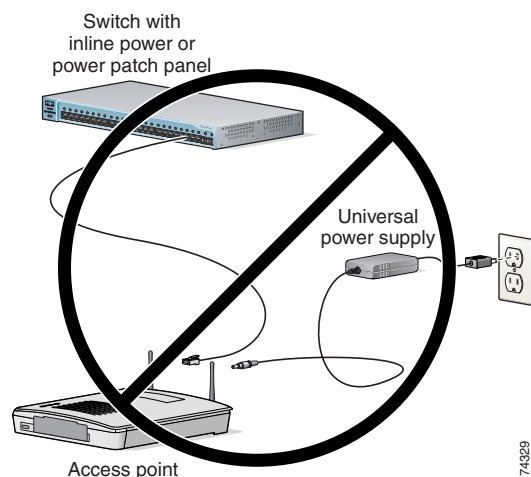
**Figure 1** *Improper Power Configuration Using Two Power Sources*

You cannot provide redundant power to 1100 and 1200 series access points with both DC power to its power port and inline power from a patch panel or powered switch to the access point's Ethernet port. If you apply power to the access point from both sources, the switch or power patch panel might shut down the port to which the access point is connected. [Figure 1](#) shows the power configuration that can shut down the port on the patch panel or powered switch.
