Release Notes for Cisco Aironet 350, 1100, and 1200 Series Access Points for Cisco IOS Release 12.2(13)JA

October 30, 2003

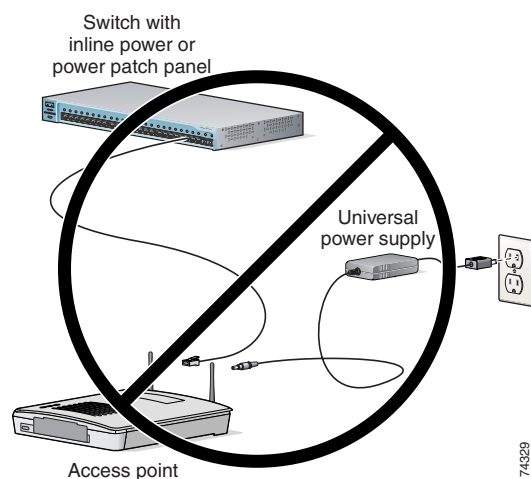
Figure 1 Improper Power Configuration Using Two Power Sources

You cannot provide redundant power to 1100 and 1200 series access points with both DC power to its power port and inline power from a patch panel or powered switch to the access point's Ethernet port. If you apply power to the access point from both sources, the switch or power patch panel might shut down the port to which the access point is connected. [Figure 1](#) shows the power configuration that can shut down the port on the patch panel or powered switch.
