Release Notes for Cisco Aironet 350, 1100, and 1200 Series Access Points for Cisco IOS Release 12.2(13)JA1

November 17, 2003

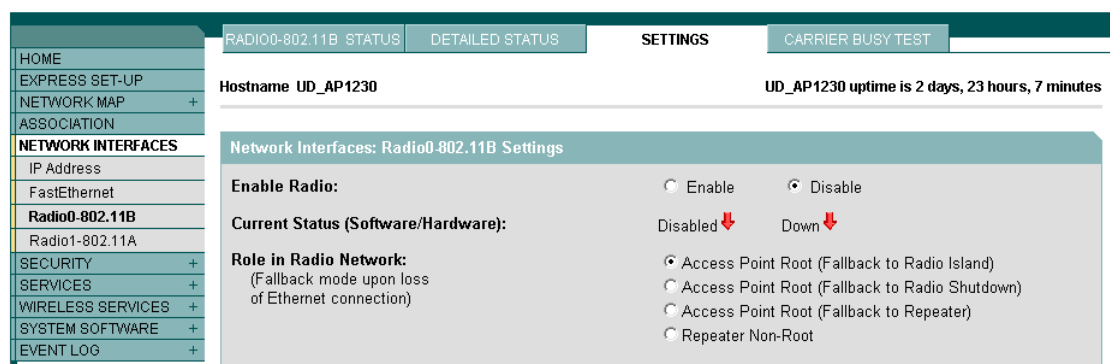
Figure 2 Network Interfaces: Radio Settings Page

If your access point runs Cisco IOS Release 12.2(11)JA, or 12.2(11)JA1 the access point might crash immediately after you upgrade to IOS Release 12.2(13)JA1. Because of a rare timing condition that affects the radios, the access point sometimes crashes immediately after the upgrade when the radios are enabled. However, when the access point reboots after the crash, the upgrade is complete and the access point operates normally. To prevent the access point from crashing, disable the radio interfaces before upgrading to IOS Release 12.2(13)JA1.

- Step 1** Browse to the Network Interfaces: Radio Settings page. [Figure 2](#) shows the top portion of the Network Interfaces: Radio Settings page.

- Step 2** Select **Disable** to disable the radio.
- Step 3** Click **Apply** at the bottom of the page.
- Step 4** If your access point has two radios, repeat these steps for the second radio.
