Release Notes for Cisco Aironet 350, 1100, and 1200 Series Access Points for Cisco IOS Release 12.2(13)JA1

November 17, 2003

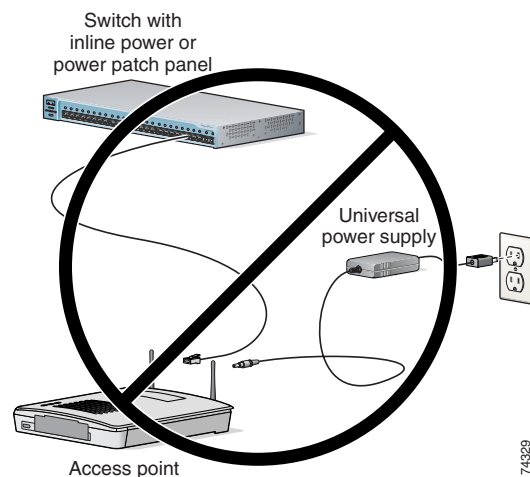
Figure 1 Improper Power Configuration Using Two Power Sources

You cannot provide redundant power to 1100 and 1200 series access points with both DC power to its power port and inline power from a patch panel or powered switch to the access point's Ethernet port. If you apply power to the access point from both sources, the switch or power patch panel might shut down the port to which the access point is connected. [Figure 1](#) shows the power configuration that can shut down the port on the patch panel or powered switch.
