Release Notes for Cisco Aironet 350, 1100, and 1200 Series Access Points for Cisco IOS Release 12.2(13)JA2

February 5, 2004

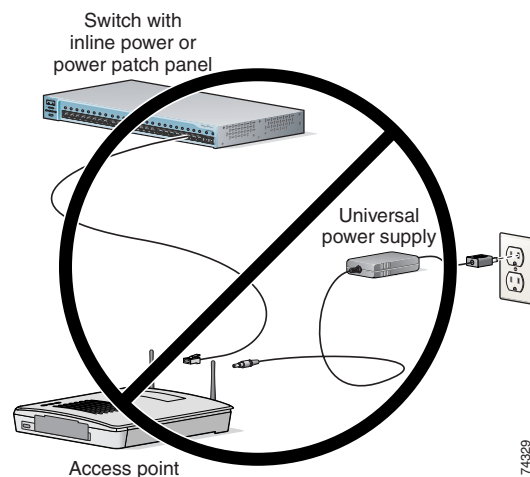
Figure 1 *Improper Power Configuration Using Two Power Sources*

You cannot provide redundant power to 1100 and 1200 series access points with both DC power to its power port and inline power from a patch panel or powered switch to the access point's Ethernet port. If you apply power to the access point from both sources, the switch or power patch panel might shut down the port to which the access point is connected. [Figure 1](#) shows the power configuration that can shut down the port on the patch panel or powered switch.
