Release Notes for Cisco Aironet 350, 1100, and 1200 Series Access Points for Cisco IOS Release 12.2(13)JA4

April 19, 2004

Cisco IOS Release 12.2(13)JA4 resolves caveats CSCdz32659, CSCed27956, CSCed38527, and CSCed40563 but does not introduce new features. These release notes describe caveats for Cisco IOS Release 12.2(13)JA4 and features and enhancements introduced in Cisco IOS Release 12.2(13)JA.

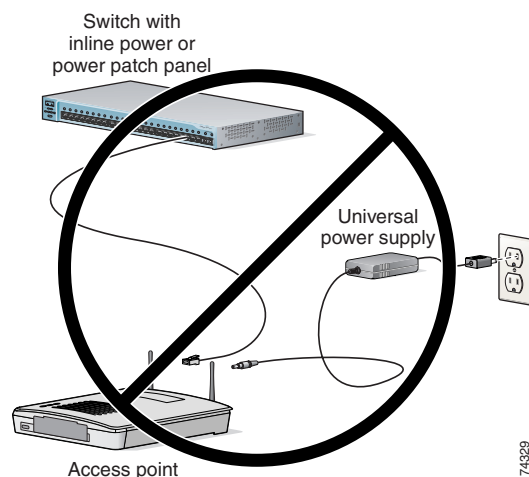
Figure 1 *Improper Power Configuration Using Two Power Sources*

You cannot provide redundant power to 1100 and 1200 series access points with both DC power to its power port and inline power from a patch panel or powered switch to the access point's Ethernet port. If you apply power to the access point from both sources, the switch or power patch panel might shut down the port to which the access point is connected. [Figure 1](#) shows the power configuration that can shut down the port on the patch panel or powered switch.
