# Release Notes for Cisco Aironet Workgroup Bridges Running Firmware Release 8.80

May 31, 2002

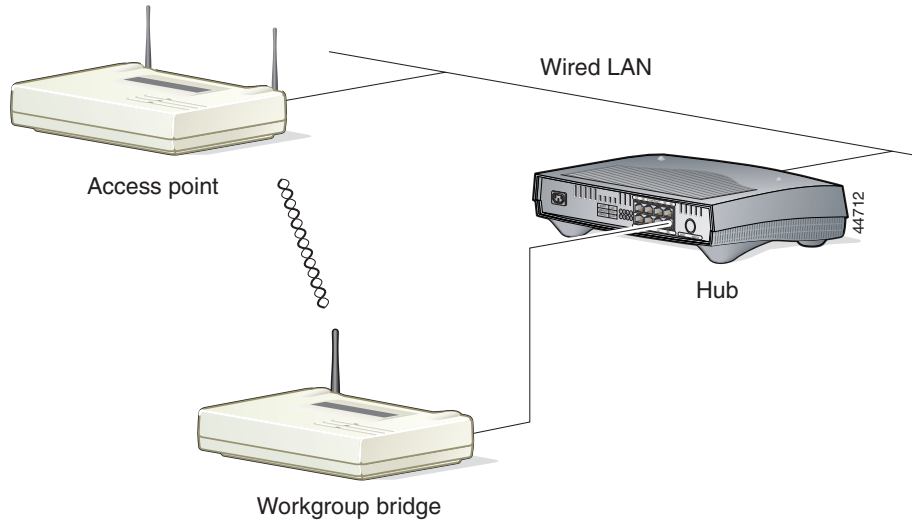
**Figure 1** Bridge Loop Caused by a Workgroup Bridge Connected to the Wired LAN

If the workgroup bridge is connected to the wired LAN and is communicating with an access point on the same LAN, a network problem known as a *bridge loop* can occur. Avoid a bridge loop by disconnecting the workgroup bridge from the wired LAN immediately after you configure it. Figure 1 shows the network configuration in which the loop occurs.

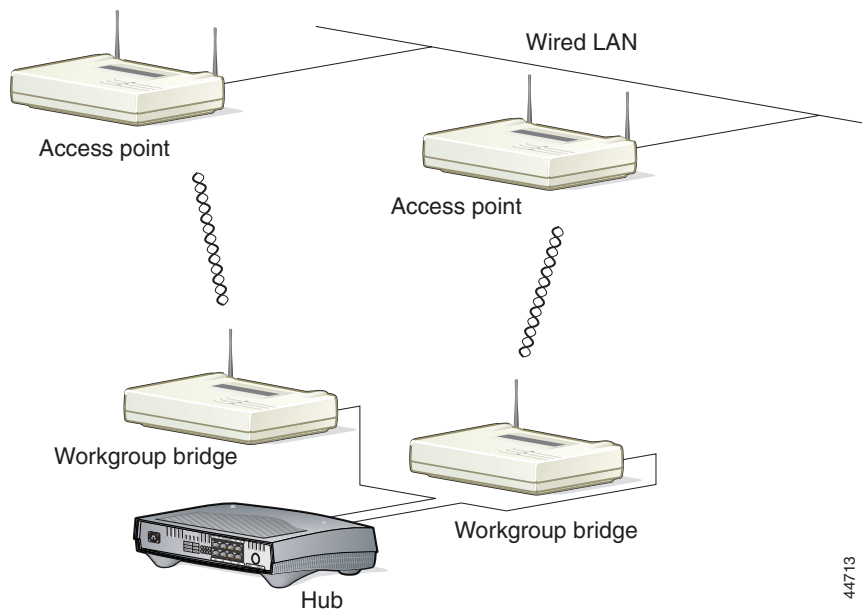
**Figure 2** Bridge Loop Caused by Two Workgroup Bridges on the Same Remote Hub

A bridge loop can also occur if two or more workgroup bridges are connected to the same remote hub. To prevent this bridge loop, always connect only one workgroup bridge to a remote hub. Figure 2 shows the network configuration in which the loop occurs.
