Release Notes for Cisco Aironet Workgroup Bridges Running Firmware Version 8.65_2

February 12, 2002

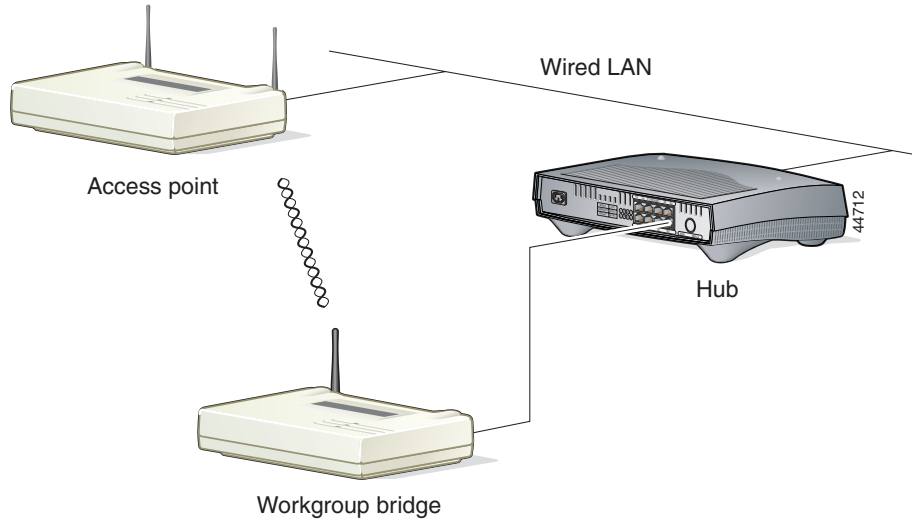
Figure 1 Bridge Loop Caused by a Bridge Connected to the Wired LAN

If the bridge is connected to the wired LAN and is communicating with an access point on the same LAN, a network problem known as a *bridge loop* can occur. Avoid a bridge loop by disconnecting the bridge from the wired LAN immediately after you configure it. Figure 1 shows the network configuration in which the loop occurs.

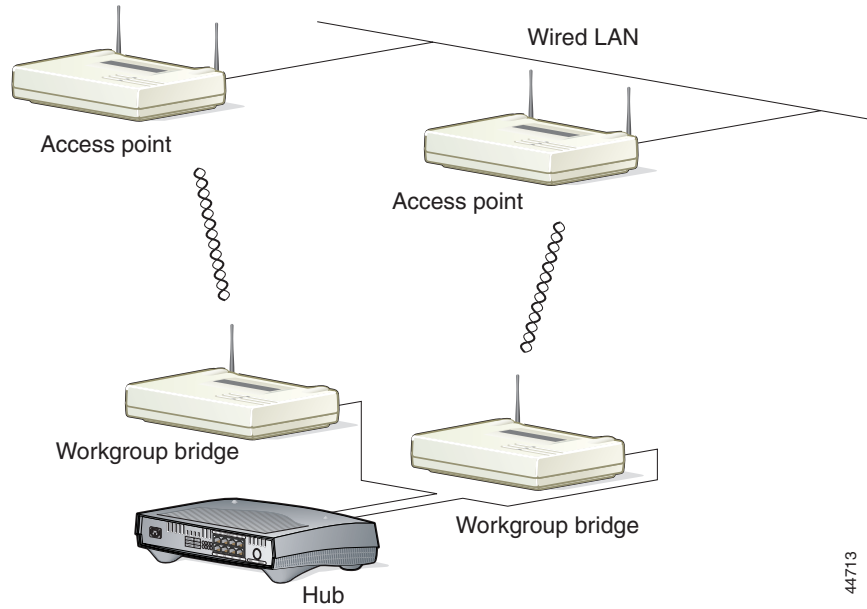
Figure 2 Bridge Loop Caused by Two Bridges on the Same Remote Hub

A bridge loop can also occur if two or more bridges are connected to the same remote hub. To prevent this bridge loop, always connect only one bridge to a remote hub. Figure 2 shows the network configuration in which the loop occurs.
