# BTM AIS (Blue) Errors

Document ID: 10844

This error applies to the IGX broadband trunk module (BTM) with T3, E3, and E1 backcards.

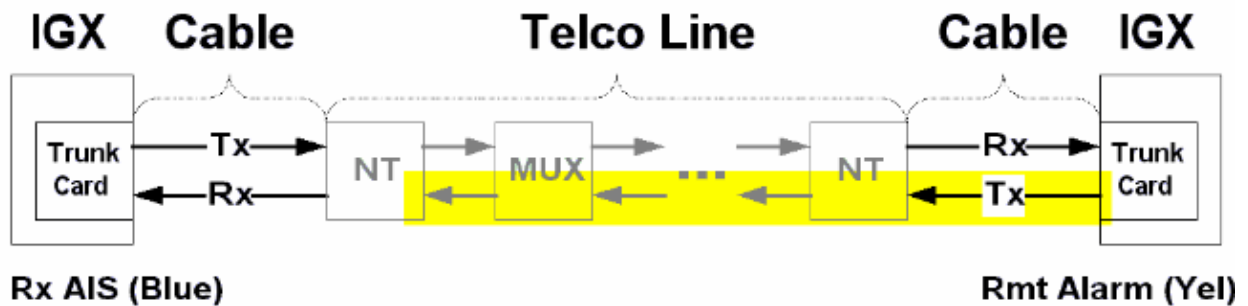
18.gif

The likely location of equipment errors is highlighted in yellow.
