BTM C-bit Parity Errors

Document ID: 10846

This error applies to the IGX Broadband Trunk Module (BTM) with a T3 backcard.

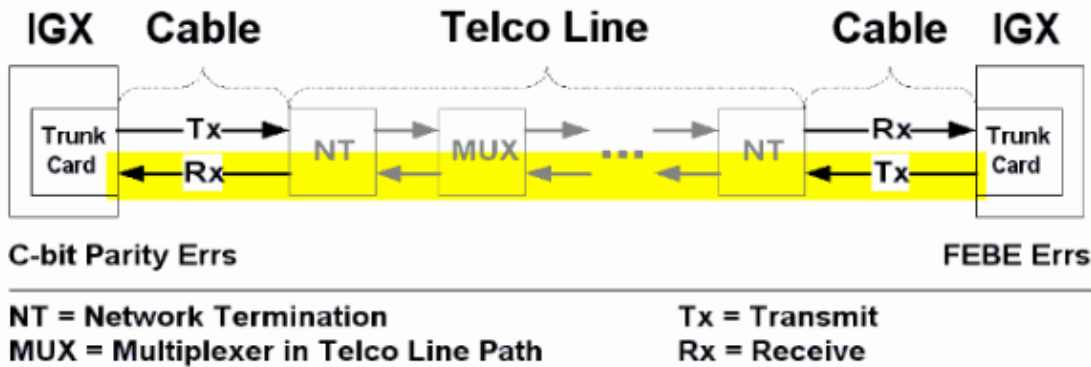
21.gif

The likely location of equipment errors is shown in yellow:
