# BTM Line Code Errors

Document ID: 10852

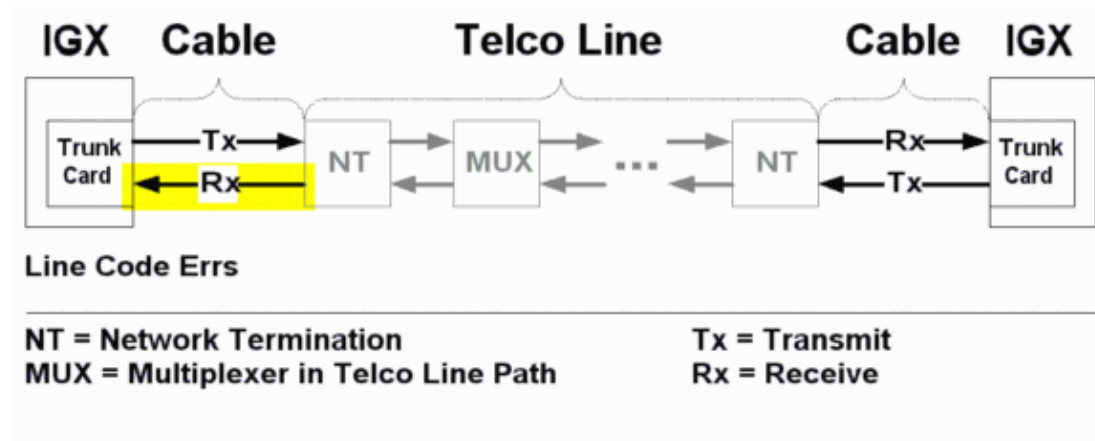
## Error Example

A `Line Code Err` typically involves a local BTM receiver, cable, or network termination (NT) transmitter. Multiplexers on the path do not relay the errors to the next cable segment. Possible causes include:

- Line code configuration mismatches
- Hardware malfunction
- Loose or unconnected shield ground wires
- Bridge taps
- Timing problems
- Electrical interference

The likely location of equipment errors is highlighted in yellow.
