Troubleshoot Analog FXO GroundStart Outbound Call Failures

Document ID: 61947

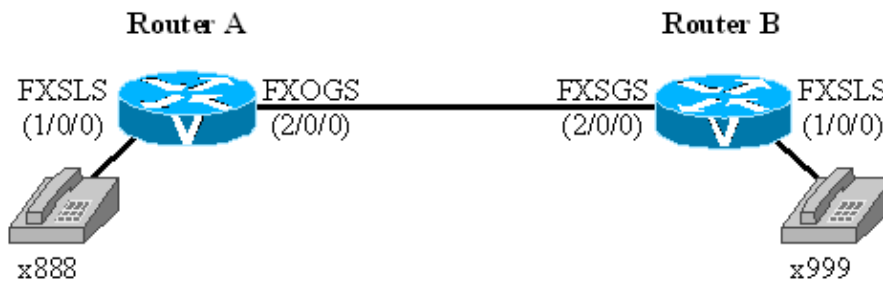
The easiest empirical way to do this is to connect the FXO port to a known functioning FXS port, such as an VIC-2FXS, VIC2-2FXS, VIC-2DID (in FXS mode), VIC-4FXS/DID (in FXS mode), NM-HDA FXS, or EVM-HD FXS port on another (or even same) Cisco voice gateway. In this case, a straight-through, two-wire RJ-11 connection should be used. The aim here is to verify that one voice gateway can signal the other over the connection and draw a dial tone from the peer gateway. A complete testing scenario for this could be:

A successful test would enable a user to pick up either analog phone and get a dial tone from the local router, dial the far-end extension to go offhook over the GS line, hear a dial tone from the peer gateway, then dial the far-end extension once again to complete the call to the far-end phone. If this works fine in both directions, then the FXO voice-port functions as expected. Be sure to check the phone call for two-way audio from both parties.

If the call attempts continue to fail or an audio problem such as one-way or no-way audio is experienced, then there may be an actual hardware problem. Check the RJ-11 cabling again, and test with another FXS or FXO voice card, if available.
