Release Notes for Cisco RV Series Multi-WAN VPN Routers Firmware Version 4.0.4.02

July 29, 2011

OL-25562-01

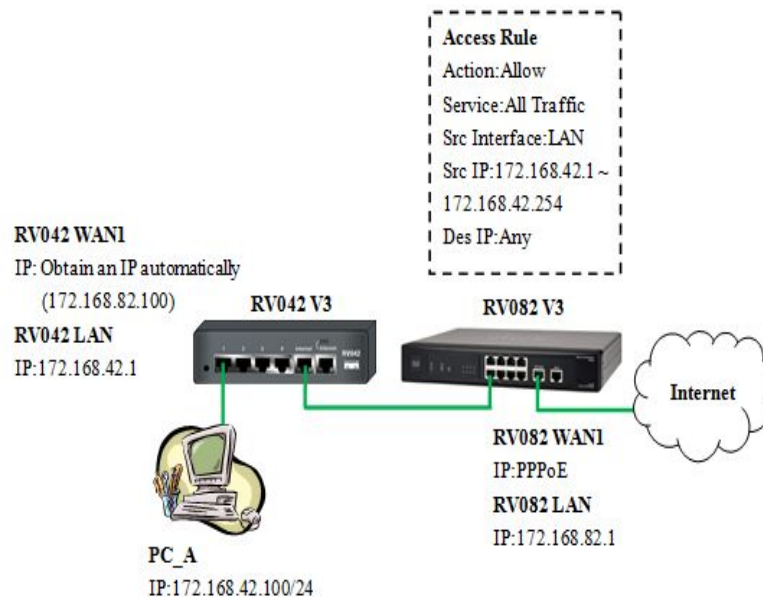
Multiple subnets on LAN issue.

- Description**—The RV0xx version 3 routers handle multiple subnets on the LAN side differently than the RV0xx version 2 routers. For example, the illustration below shows a sample network where the RV082 v3 (running in Gateway Mode, with NAT enabled) is the internet gateway and the RV042 v3 running in Router Mode is connected to the RV082 v3. To allow the computers in the LAN of the RV042 v3 to access the Internet, you need to add an Access Rule.

- **Workaround**—Add an access rule; for example, in the previous network example, the access rule would be configured as shown below:
