Release Notes for Cisco Video Surveillance Manager, Release 7.14.7

Revised: July 7, 2023

This document provides important information for Release 7.14.7 of the Cisco Video Surveillance Manager (Cisco VSM).

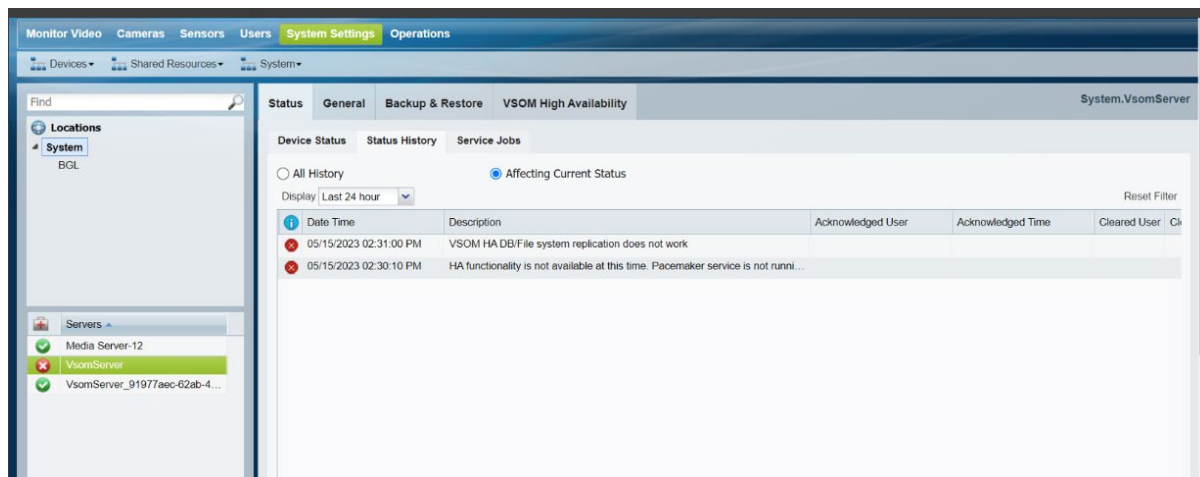
2. Defect ID: CSCwf33565: Add VSOM-HA job completes successfully but system raises critical error on VSOM server.

Error is reported because initially master server is unable to populate entries for VSOM-HA related tables in the database, however when user performs below workaround the affected server is able to replicate missing data from peer.

HA functionality is not available at this time. Pacemaker service is not running.

```
service pacemaker stop
```
3. The system will take a while after which the server that was configured initially as Primary will regain master role.
4. Login through VIP and check VSOM High Availability Tab to confirm that master role is acquired mentioned in point 3 above.
5. If status Page of primary VSOM shows critical error "VSOM HA DB/File system replication does not work", then perform "Replace HA"

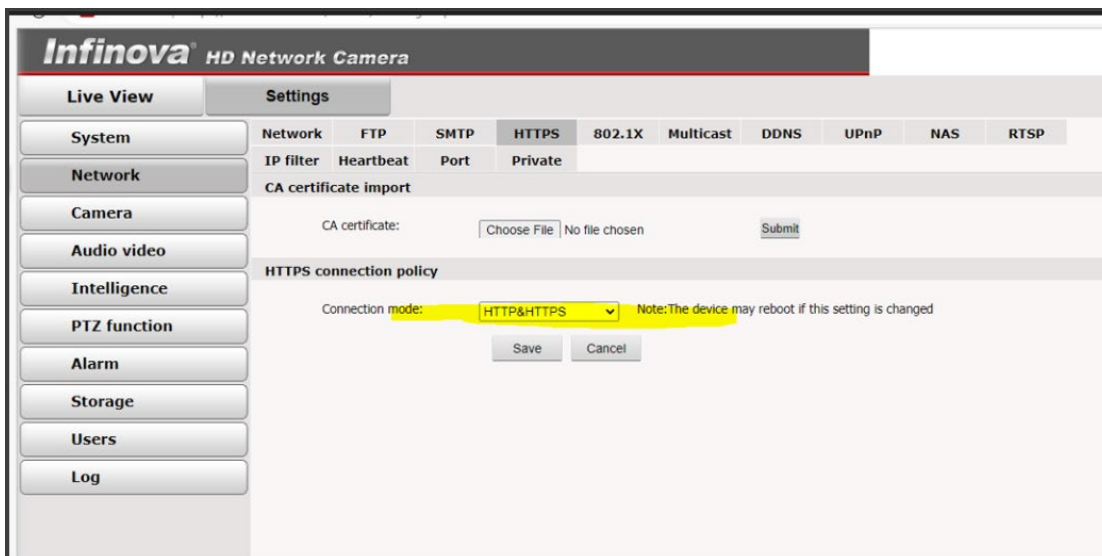
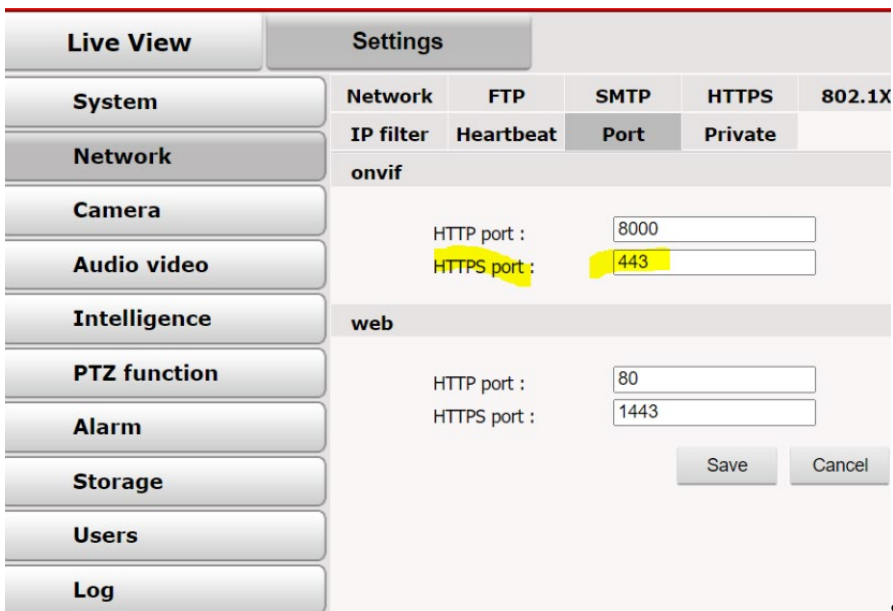
3. Defect ID: CSCwe84022: System fails to add Infinova camera as Onvif

System fails to add Infinova camera as Onvif.

On factory reset, Infinova camera comes with any HTTPS port (Like 1443). In VSOM, There is no provision of giving custom HTTPS port for Onvif make model while adding camera. VSM by default uses port 443 for Onvif HTTPS communication. If camera UI has Onvif HTTPS port other than 443, Camera add will fail.

For **V4.9.0.201906211448** firmware version: User should set Onvif HTTPS port to 443 from Camera-UI prior to adding camera to VSOM as Onvif model. Also after factory reset, the camera will have "HTTP and HTTPS(Both)" mode enabled. Since VSOM doesn't have provision to assign custom HTTPS port for Onvif camera, the user needs to set Onvif HTTPS port to 443 from camera UI.

For **V3.4.0.201703271558** firmware version: After factory reset, the camera has HTTP only mode enabled. Here the user doesn't need to set HTTPS port from camera UI.

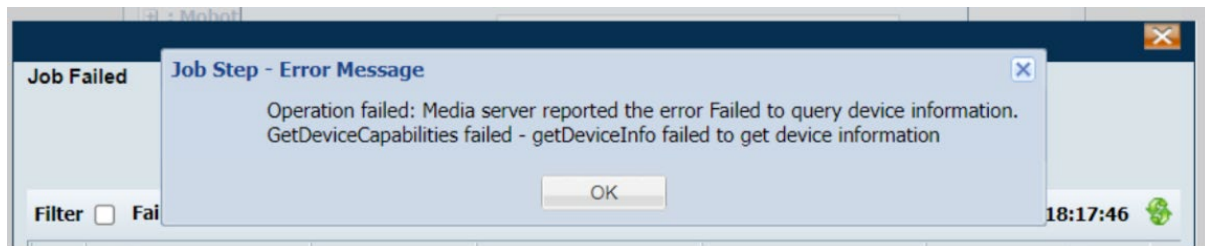
4. Defect ID: CSCwe58132: System fails to create Onvif model for Onvif conformant devices.

System fails to create Onvif model for Onvif conformant devices.

During analysis it was found that VSM does not provide the capability to configure NTP and time zone settings. Since product has reached its end-of-life (EOL), no further fixes can be provided.

Failed to query device information. GetDeviceCapabilities failed - getDeviceInfo failed to get device information

User should first set NTP and timezone on camera from camera UI and then create Onvif model on VSOM-UI.

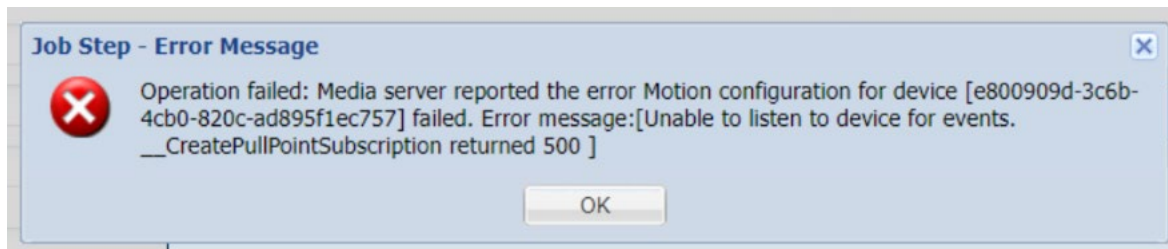
5. Defect ID: CSCwe98260: Motion detection and events not supported on Vivotek-SD-9361-EHL with 0114 firmware.

Media server reported the error Motion configuration for device. Unable to listen to device for events. __CreatePullPointSubscription returned 500

Issue is found to lie on camera's end. No workaround can be provided on VSM. User can attempt to upgrade firmware which supports PullPointSubscription and check if it helps in resolving the issue.

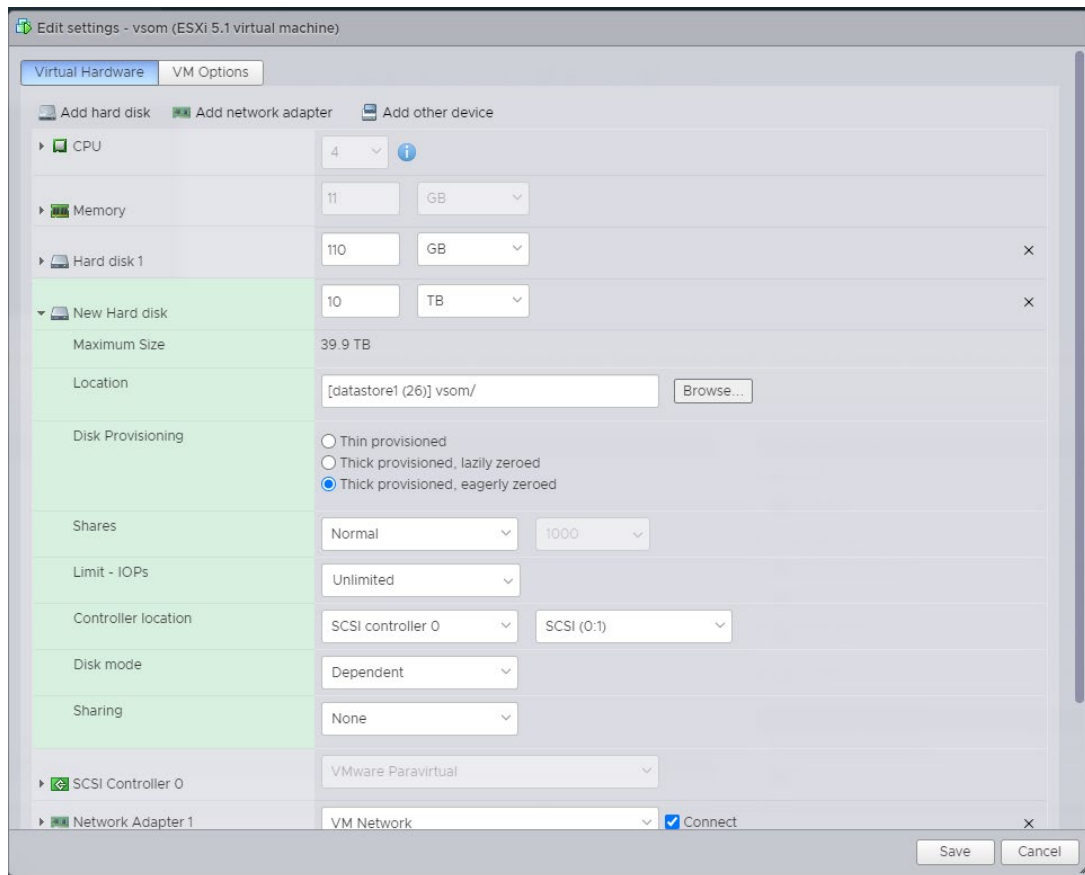
Cause of such issues could be hardware/server specific. The issue was not reproducible on other machines. However, below workaround for any such issues could help to resolve.

1. Go to the respected VM by login in using ESXi or VCenter.
2. Select the “Edit” option in VM.
3. Now click on the “add hard disk” option (e.g., Add 10TB disk).
4. Follow the below snippet to config disk parameters -

5. Click on the “Save” option once disk configuration completes.

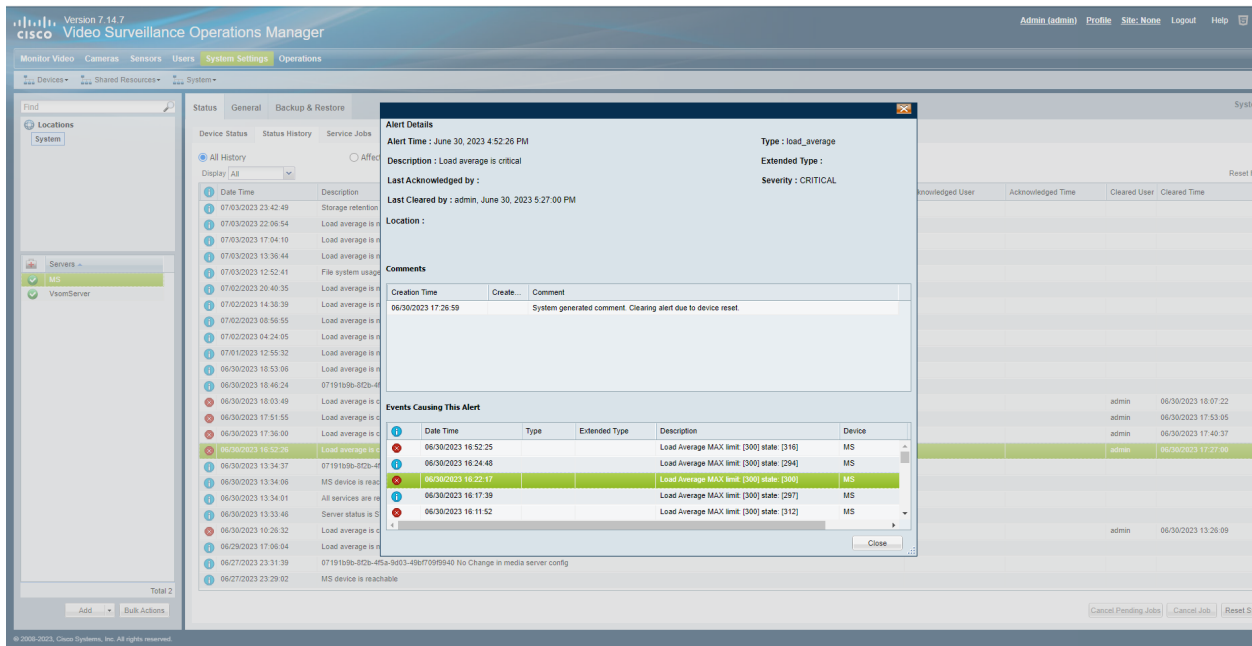
12. Defect ID: CSCwf82805: VSM 7.14.7: Load Average Critical Alert on Media Server Performance Setup

Apart from this load average critical alert, not observed any other alert or error on this server, IO wait on the disk also low which is around 12% to 15%.

Error: "Load average is critical"

If you do not want to see stale load average critical alerts, then scale up the 15 min load average value from 12 to 18, to which scale value is 450.

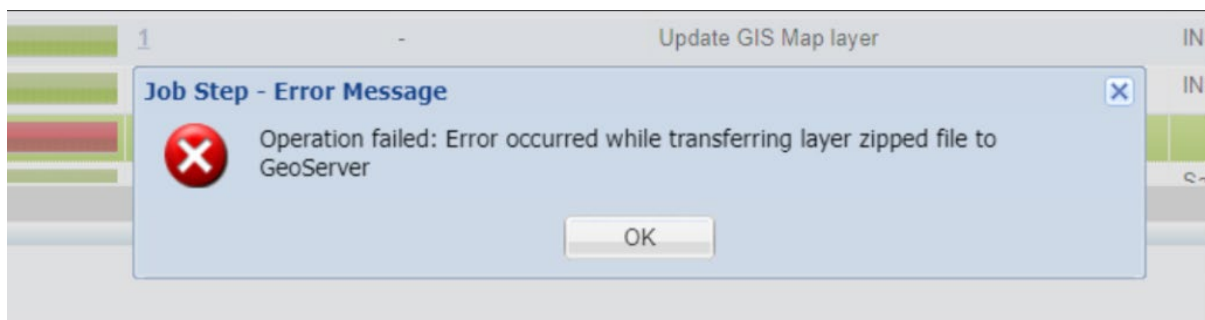
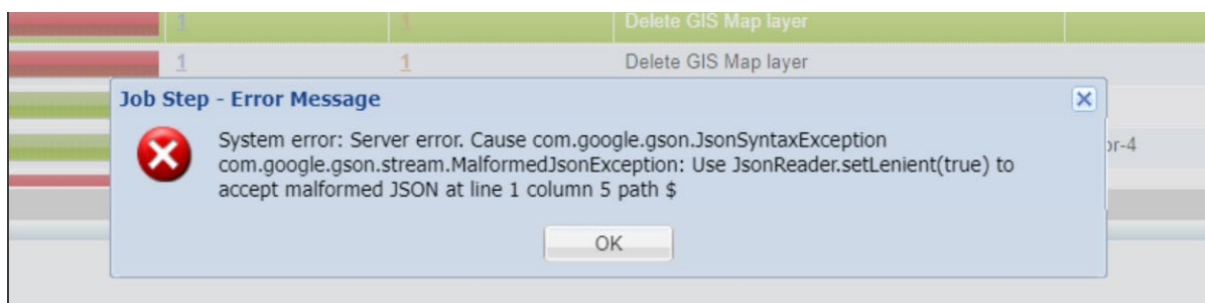
While user tries to add/delete Image layers, the job fails with below mentioned error.

Error occurred while transferring layer zipped file to GeoServer.

This was observed to be an intermittent issue. The job completes successfully on another attempt.

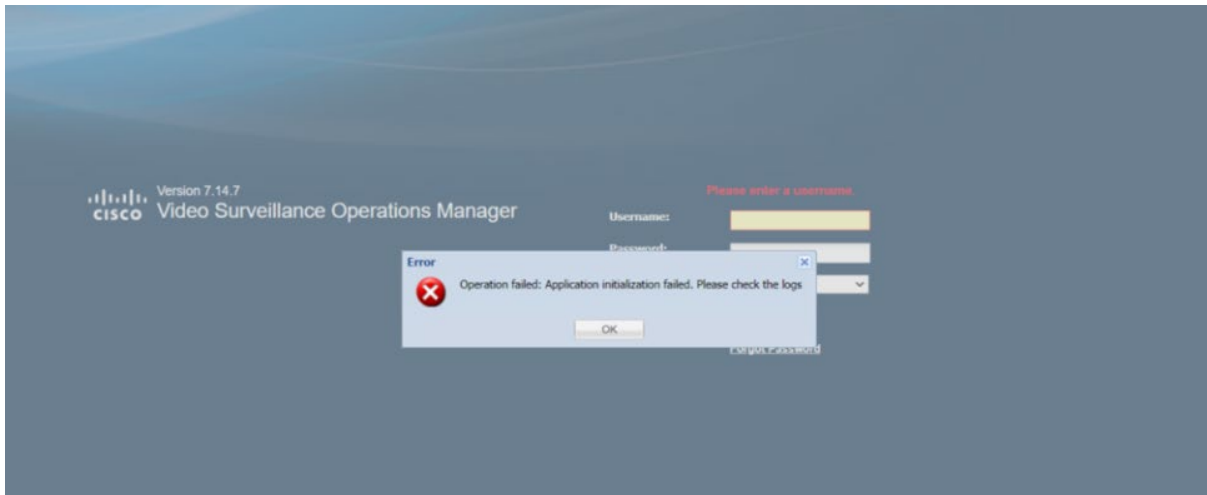
System reports '*Application Initialization failed*' error when server is deployed using OVA.

This is an intermittent issue caused by timeouts during the initialization process. User can instead use below workaround to overcome the issue.

Application initialization failed

On affected server run command - `sudo su service cisco restart`

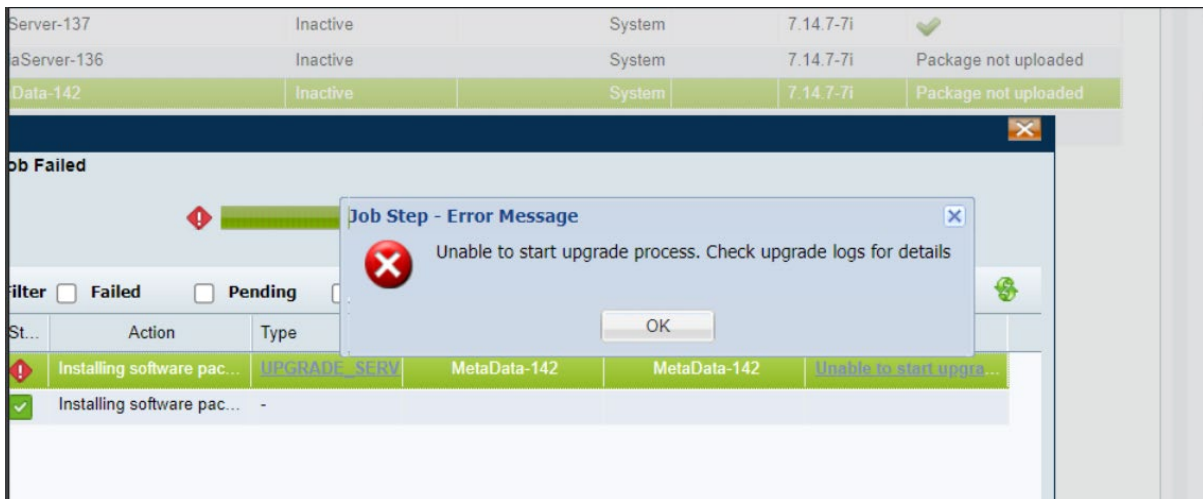
Defect ID: CSCwd59320

An initial sub-job fails during the upgrade process from versions 7.14.5 and 7.14.6 to 7.14.7.

System throws shown error for an initial sub-job during the upgrade process. However, despite the sub-job failing, the system is still able to proceed and successfully complete upgradation.

Unable to start upgrade process

No workaround needed. The shown error has no impact on upgrade and system continues to upgrade successfully.

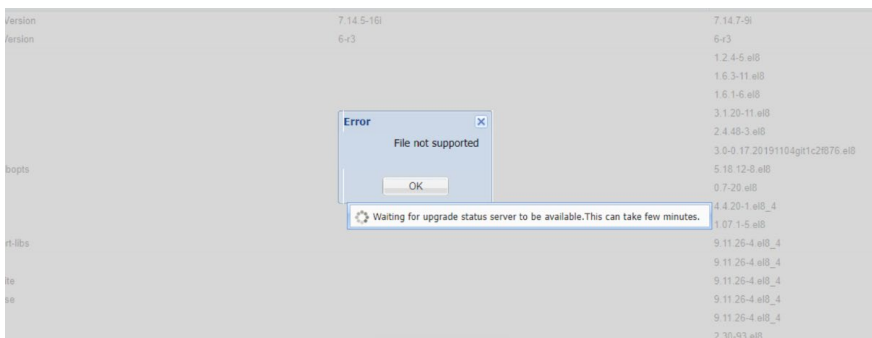
**Defect ID:** CSCwd82293

Redundant Pop-up Alert showing up - File not supported, while upgrading to 7.14.7 from CDAF server. This is an internal error caused due to an unsupported file type is in VSM software.

*File not supported.*

No workaround needed. This error is just dialog box. Irrespective of user intervention upgrade process runs smoothly and successfully.

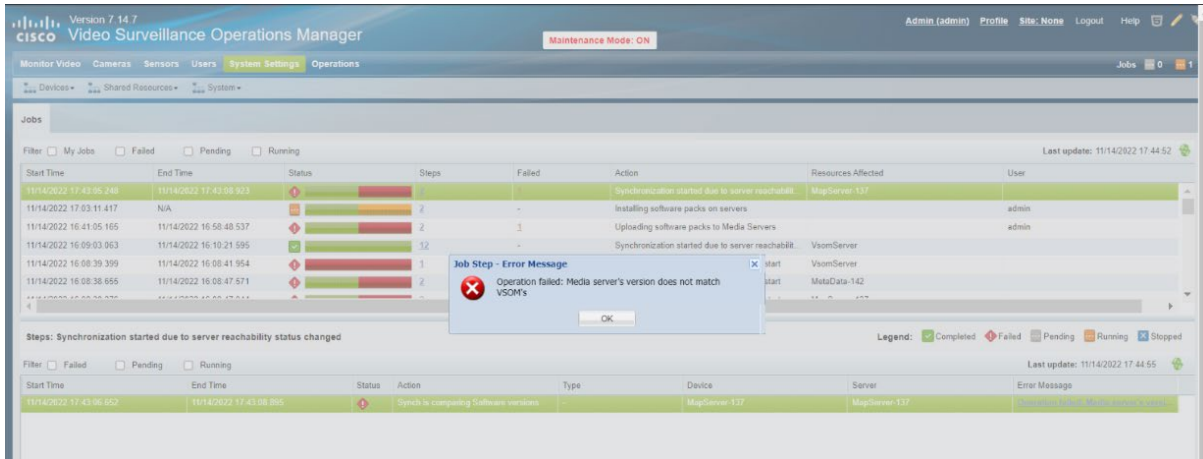
**Defect ID:** CSCwd61839

Redundant Synchronization job internal to upgrade process are failing during upgrade.

No workaround is needed. These job failures can be ignored since they don't impact upgrade.
