Cisco RF Gateway 1 Software Release 3.01.08 Release Note

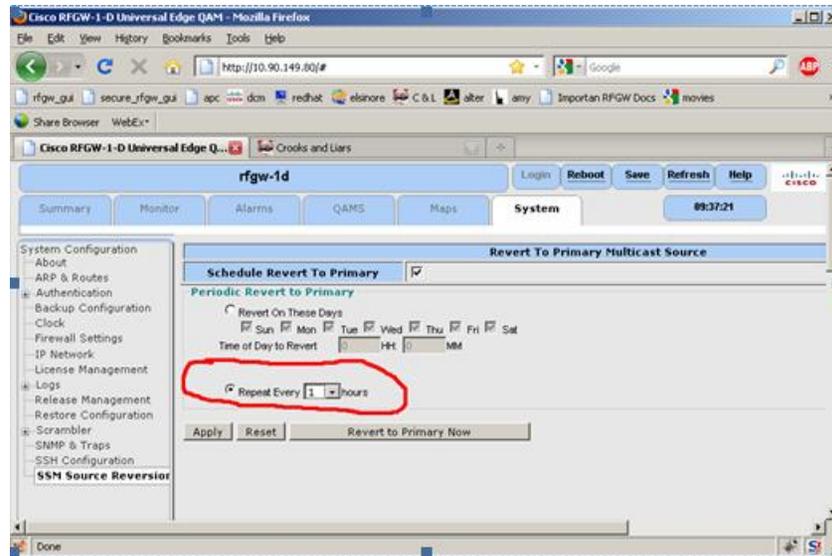
- When using the *Revert to Primary* option, select all the days of the week using the *Revert On These Days* option. See screen below. Depending on the operating conditions, the actual repeat cycle can increase from the initial set value by as much as one hour per week.

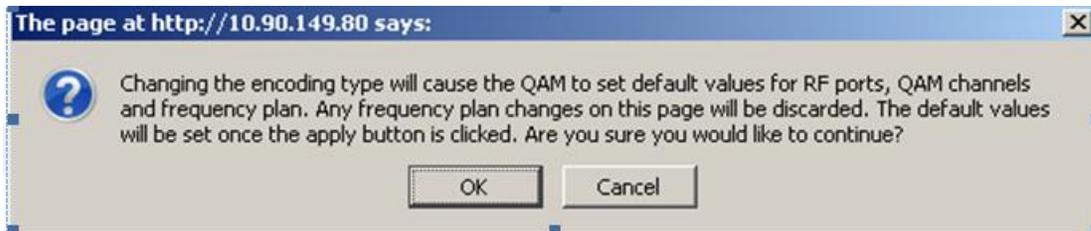
Result: The following message is displayed.

The following special upgrade steps must be followed if the QAM encoding type is set to ITU-A and an 8 channel per-port license is to be installed after the upgrade.

- 1 Record the settings for RF ports, QAM channels, and frequency plan as they will be set to default values in a later step.
- 2 Upgrade to 3.01.08.
- 3 Install the 8 channel per-port license.
- 4 Set the QAM encoding type to ITU-B.

- 5 Press **OK**.
- 6 Set the QAM encoding back to ITU-A and restore the QAM settings.
