日本市場向け Cisco Unified Communications 10.0 システム リリース テスト結果サマリ

2014 年 5 月
シスコ システムズ 合同会社

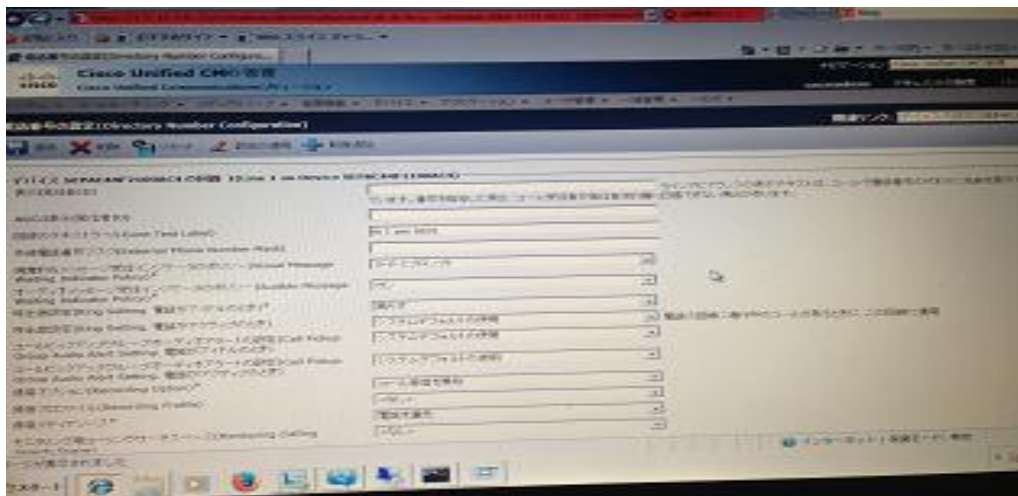
CSCuj76467: Audible Message Waiting indicator is not working in 8831 IP Phone(N-New)

Problem Description : When receiving voicemail in 8831 IP Phone there is only message waiting indicator no Audible MWI.

Expected Behaviour : when receiving a voicemail both MWI and AMWI will be there

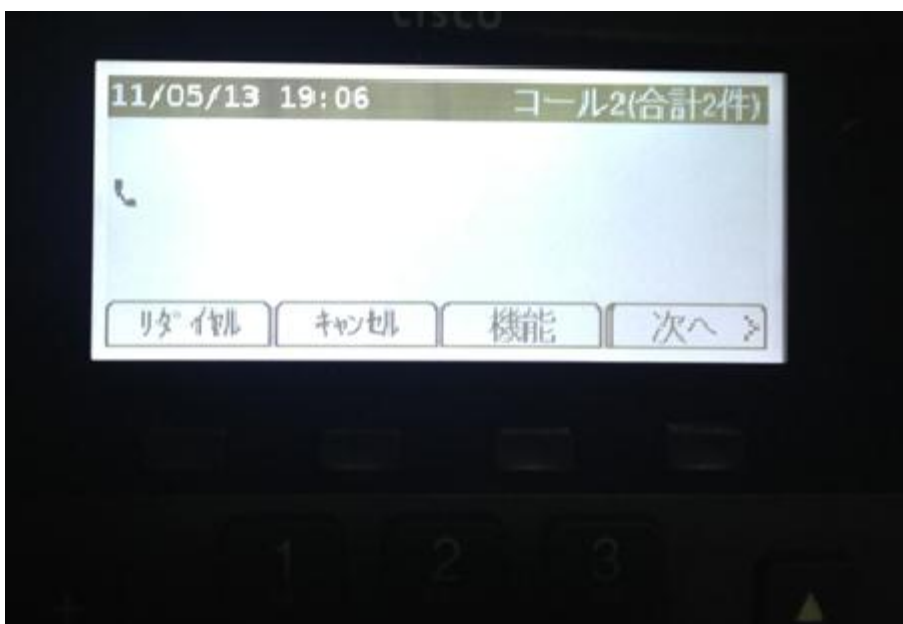
Screen Shot1:

CSCuj93496: "Enter the number to transfer" option is not found in 8831 (N-New)

During transfer, user is not prompted with option "Enter the number to transfer" after pressing the transfer softkey but the same is found in other IP Phones.

User is not prompted with the option "Enter the number to transfer" in 8831 after pressing the transfer softkey

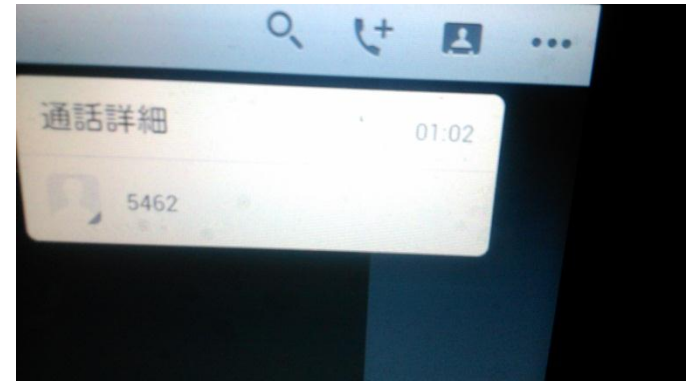
CSCum79058 : Details showing wrongly at the time of conference in DX650 (N-New)

Actual Behavior: Now the three phones are in conference, and if hold is pressed in DX650 and if I press the "Details" means it is showing only the DN of Phone B. Phone A details is not displayed. Note: In the above scenario DX650 is not the initiator of conference, but if suppose DX650 is the initiator of the conference means(i.e. when the Phone A calls to Phone C and Phone C starts the conference and joins Phone B) at that time if hold is pressed, and in "Details" it is showing the details of all the three phones.

At the time of conference if hold is pressed also it needs to show the details of all the three phones that are in conference.

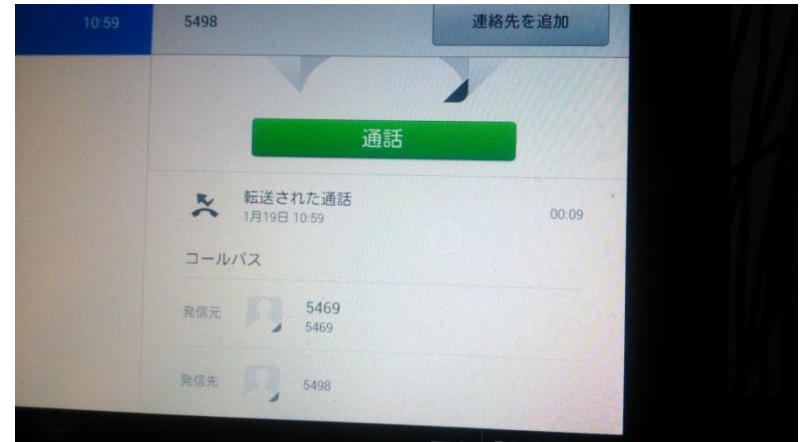
CSCum81613 : FOR DN is displayed wrongly in DX650 when CFA is set. (N-New)

After ending the call go to RECENT tab in DX650 and check the call history of this call under ALL calls. Calling DN will be 5498 in that From will be 5469 and For will be 5498. From DN is displaying correctly but the For DN it is wrongly displaying the DN of calling party DN.

In that Recent call history For DN should be 5462. But it is wrongly displayed.

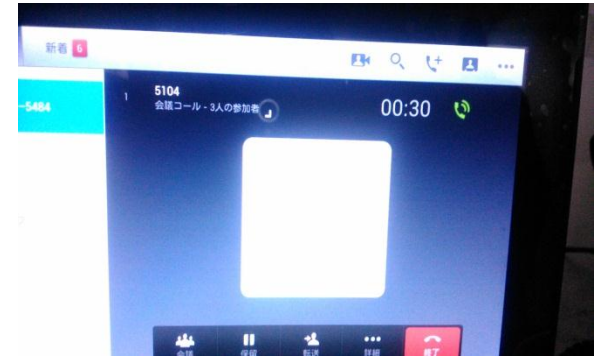
CSCum81627 : Conference members count is not decreasing in DX650 when in conference (N-New)

Now end the call in Phone D. Still in DX650 it is showing as 3 others in conference. The count needs to be decreased and it should show as 2 others in conference.

When a call is disconnected in conference, the conference members count in the DX650 should be decreased.

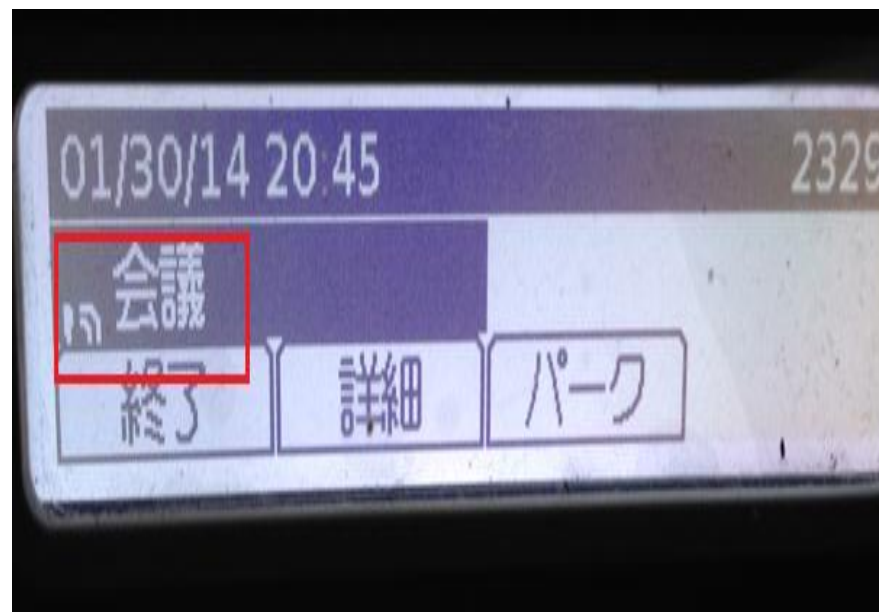
Screen Shot1:

CSCum82008 : No conference timer on 6921/61 phones while pressing Details soft-key (N-New)

Display issue on 6921 and 6961 phones while pressing Details soft-key before answering conference call i.e, No Timer is displayed for Conference call on the phones when following the below procedure.

No Timer is displayed for Conference and improper display is found on phones

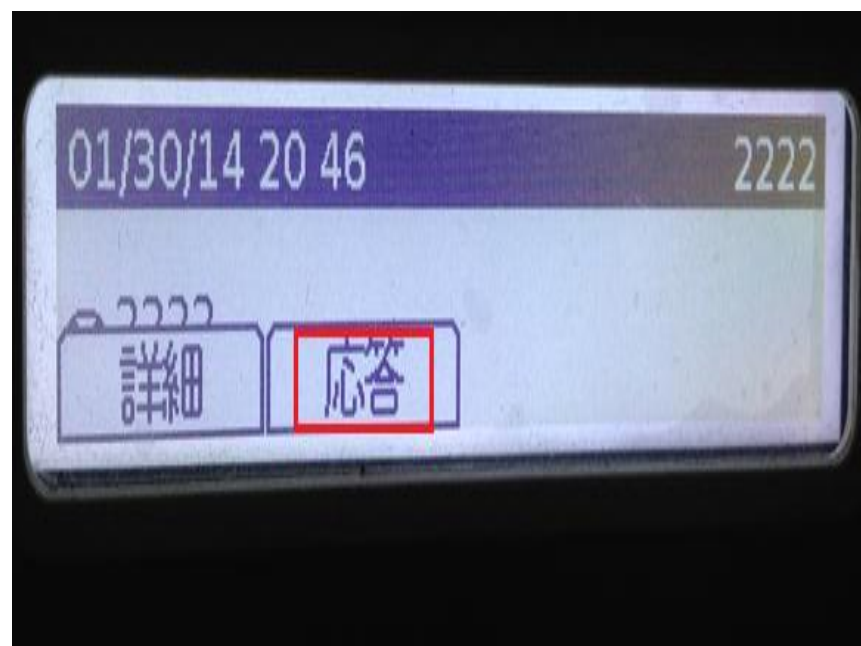
Screen Shot1:

CSCum81985: Unable to answer conference in SCCP load after pressing Details soft-key (N-New)

Unable to answer the conference call in SCCP phone load of 6921/6961 phones after pressing the Details soft-key

Unable to answer the conference call in SCCP load after pressing the details soft-key

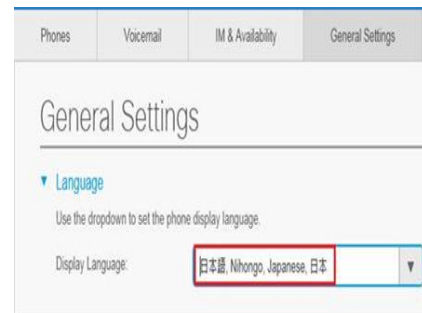
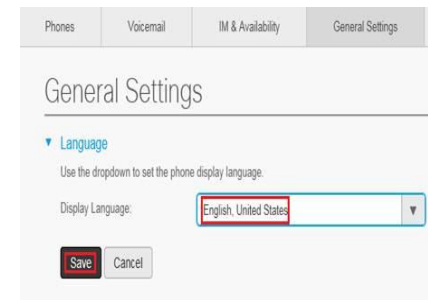
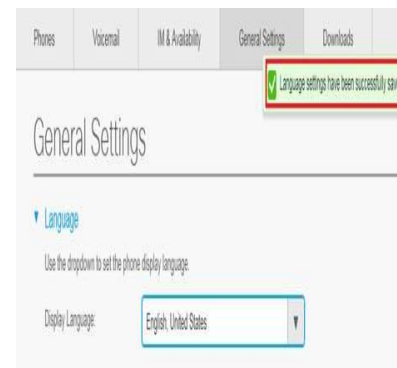
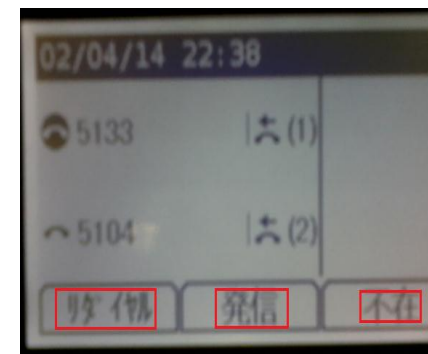
Screen Shots:

CSCun02402: Phone display language is not updated immediately to phones (N-New)

The phone display language is not updated immediately after applying the language to phones via 10.0.1 Self-Care portal

Phone display language is not applied to phones immediately when done via 10.0.1 Self-Care

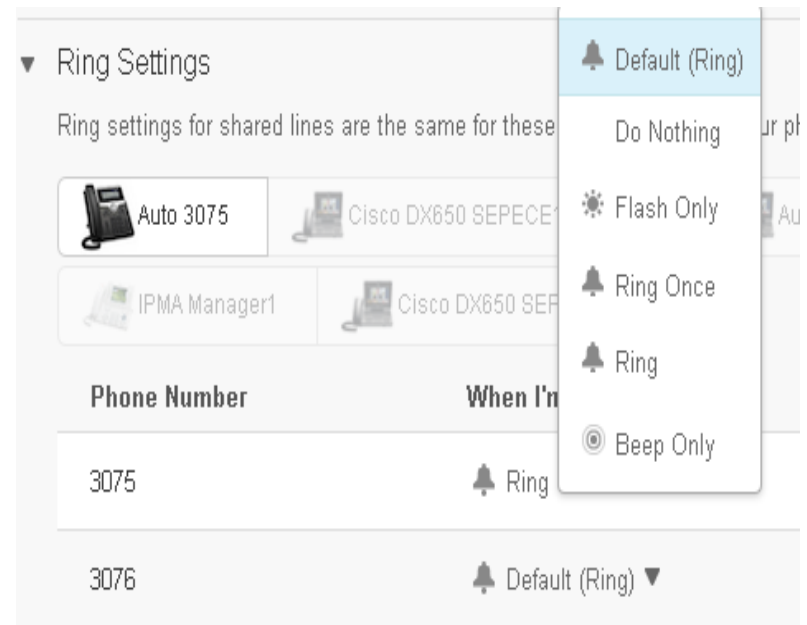
Screen Shot:

CSCun27648: 78xx:Phone do not get any ringtone when Default(Ring) is set to phones (N-New)

Phone does not get any ringtone when Default(Ring) is set to phones under When I'm on a call tab via Self-Care

Phone A is not getting any ring tone when Default(Ring) is set to phones via Self-Care and when on active call

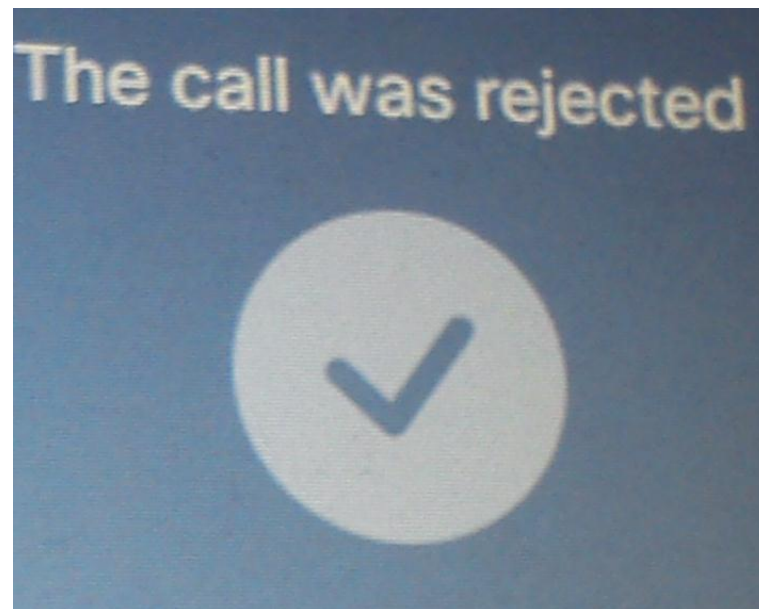
CSCum74055: Unable to transfer call from EX90 registered in Cisco VCS (N-New)

Issue-Description: When there is call between EX90 registered in Cisco VCS and EX60(1) registered in Unified CM and EX90 transfers the call to another EX60(2) registered in Cisco VCS , the transfer fails and gives call is rejected message

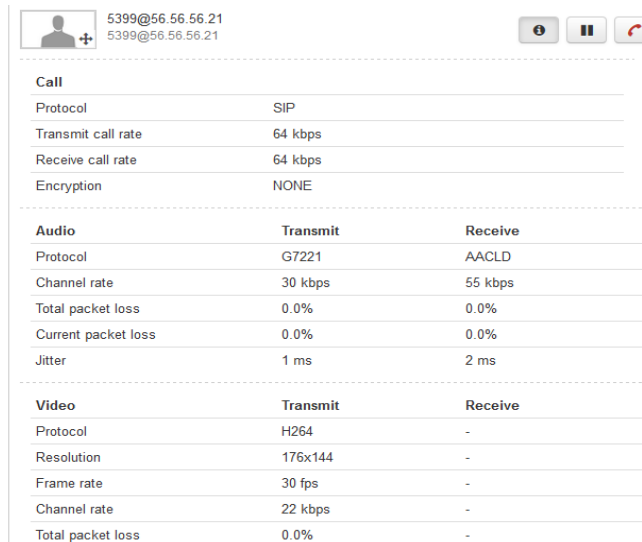
CSCun28040 : SX20 transmitting video after setting default call rate as 64 kbps (N-New)

Issue-Description: When we set the default call rate as 64 Kbps in the web-gui of SX20 and now when we make a call from SX20 to EX90, SX20 is transmitting video.

- Register SX20 Quickset in Unified CM
- In SX20 Quickset web-gui, go to Configuration -> System Configuration
- Go to Conference and change the default call rate to 64 Kbps
- Now in the Touch UI check the bandwidth rate for the call.
- The bandwidth rate shows 64 Kbps and audio, eventhough 64 Kbps is the lowest bandwidth for the call

At 64KBPS only audio should be transmitted
