BTM P-bit Parity Errors

Document ID: 10858

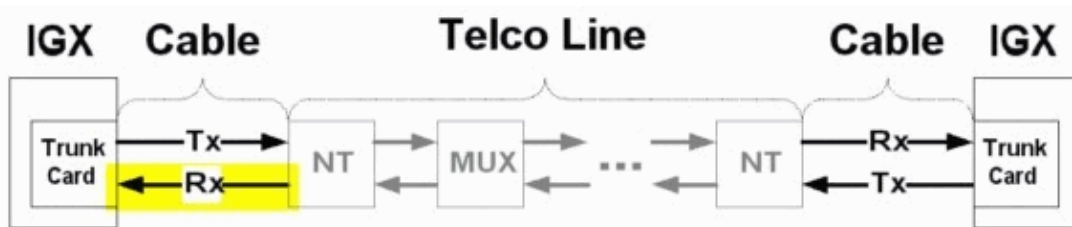
P-bit Parity Errs

The likely location of equipment errors is highlighted in yellow in this diagram:
