BTM P-bit Parity Errors

Document ID: 10858

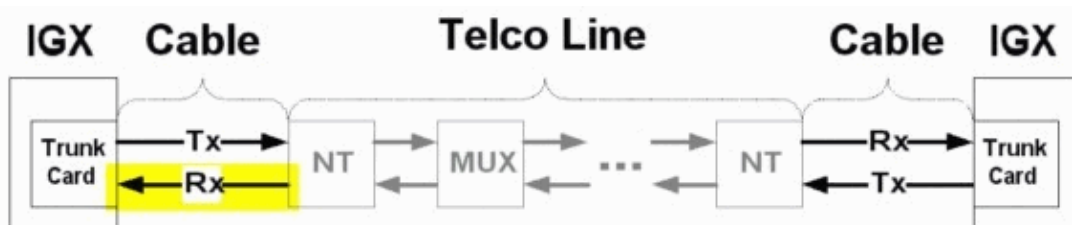
P-bit Parity Errs

The `P-bit Parity Errs` counter indicates that in-service bit errors have been received during transmission. There are two P-bits that contain parity information in the digital signal level 3 (DS3) frame. The P-bits are located in the first bit position in block 1 of subframes 3 and 4. The DS3 source computes parity over all DS3 information bits after the first X-bit in a DS3 frame. The computed parity information is inserted in the two P-bits of the subsequent frame. The value of both P-bits is always the same. Both P-bits are set to 1, if the previous DS3 frame contained an odd number of ones; both P-bits are set to 0, if the previous DS3 frame contained an even number of ones. Because P-bits are recomputed by each facility section of the DS3 path, they do not provide a way to monitor the path from end-to-end.

The likely location of equipment errors is highlighted in yellow in this diagram:

1. Issue the **dsprks** command to verify that the trunk is active. If the trunk number is not displayed in the **dsprks** command output, then the trunk is not active. To activate a trunk, issue the **uptrk** command.

2. Check cabling between the BTM and the next device upstream. Typically, the next device upstream is the local Network Termination (NT).
 - a. Leave the local cabling connected to the BTM interface card, but remove it from the NT.

- b. With the appropriate BNC connector, connect the transmit (Tx) connector to the receive (Rx) connector of the open cable, to loop it back to the local BTM interface card. Alternatively, place the local NT into the metallic loop toward the local trunk module of the Customer Premises Equipment (CPE). In this example, the CPE is the Cisco IGX BTM interface card.

- c. If the trunk status in the **dsprks** command output changes to `Clear-OK` and the **dsprkerrs** command no longer shows incremental errors, then the cable and the local trunk module are working properly.

3. Place a loopback cable onto the connectors at the interface card of the BTM, to check the local hardware. If the trunk status in the output of the **dsprks** command changes to `Clear-OK` and the **dsprkerrs** command output no longer shows incremental errors, then the BTM and interface card are working properly.

- a. Wait at least ten seconds longer than the timer setting in the **cnftrkparm** command to verify the trunk status change.
 - b. Replace the cabling and verify whether the **dsptkerrs** command output no longer shows incremental errors.
4. Check the local NT. If the NT is the Telco property, ask the Telco to test it.
