## Introduction

This document describes a problem that is encountered when a **Duplicate IP Address 0.0.0.0** error message is received by clients who run Microsoft Windows Vista and later versions. The methods that are used in order to resolve and troubleshoot the problem are also described.

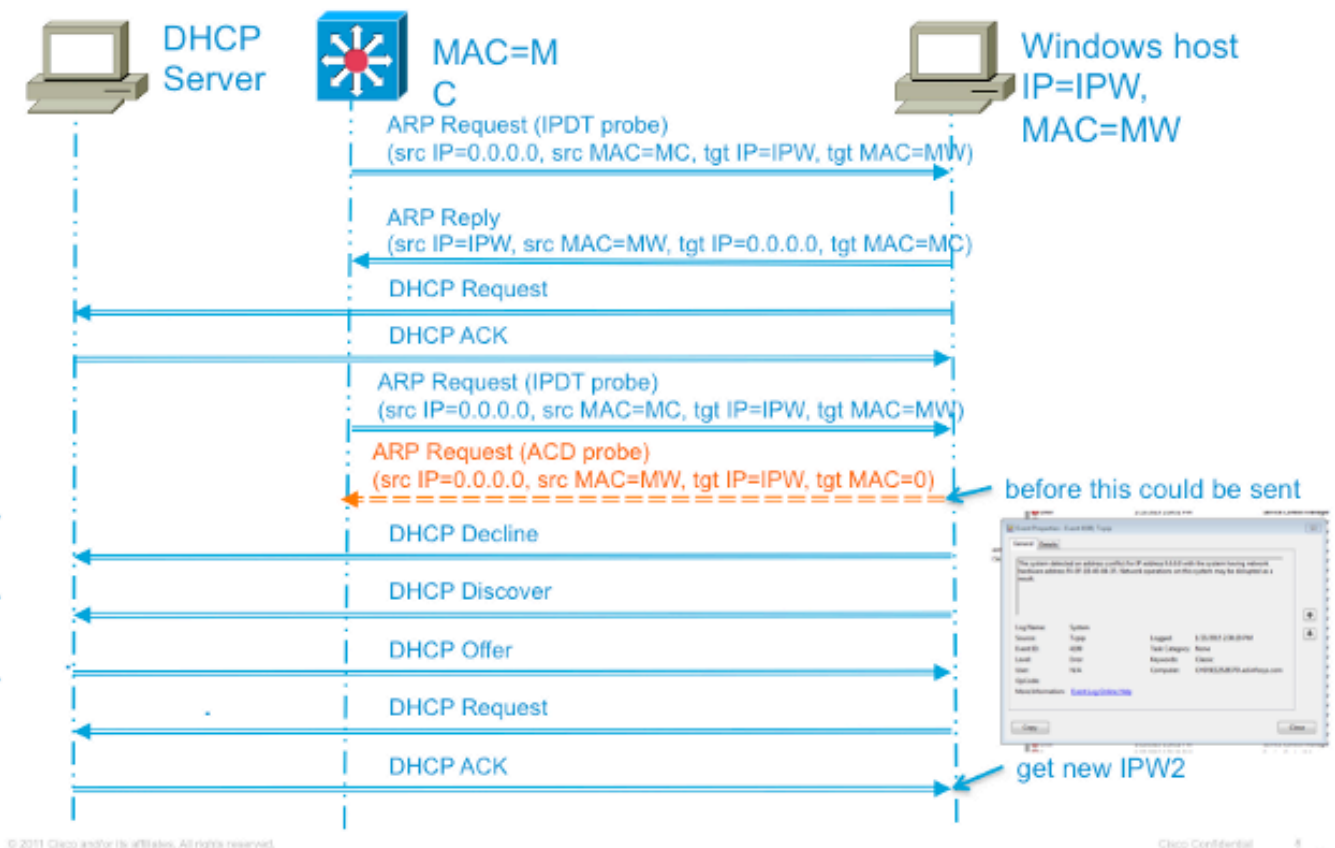
## Failing Sequence Packet Flow

If the switch sends out an ARP Probe for the client while the Microsoft Windows PC is in its duplicate-address detection phase, then Microsoft Windows detects the probe as a duplicate IP address and presents a message that a duplicate IP address was found on the network for 0.0.0.0. The PC does not obtain an address, and the user must either manually release/renew the address, disconnect and reconnect to the network, or reboot the PC in order to gain network access.

Here is an example of the failed packet sequence:

- The most effective method that is used in order to prevent this issue is to configure the switch so that it sends a non-RFC compliant ARP Probe to source the probe from the Switch Virtual Interface (SVI) in the VLAN where the PC resides. If an SVI is configured for the VLAN and either of the two commands that follow are used, then the sender IP address in the IPDT probes will never be 0.0.0.0. Thus, it is certain that the duplicate IP address error will not occur.

- The primary non-SVI alternative that is used in order to work around the issue is to delay the probe from the switch so that Microsoft Windows has time to finish the duplicate IP address detection. This is effective only on access ports and link-up scenarios. Enter this command in order to delay the probe:

`ip device tracking probe delay 10`The RFC specifies a ten-second window for duplicate address detection, so if you delay the device-tracking probe, it resolves the issue in nearly all cases. In addition to probe-delay, the delay also resets when the switch detects a probe from the PC. For example, if the probe timer has counted down to five seconds and detects an ARP Probe from the PC, the timer resets back to ten seconds. This window can be further reduced if you enable DHCP snooping as well, as this similarly resets the timer. In rare circumstances, the PC sends an ARP Probe milliseconds before the switch sends its probe, which still triggers a duplicate address message to the end user. This command was introduced in Cisco IOS Version 15.0(1)SE on 2900, 3500, and 3700 Series Switch platforms, Version 15.0(2)SG on the 4500 Series Switch platform, and Version 12.2(33)SX17 on the 6500 Series Switch platform.
