Why Doesn't PIM Sparse Mode Work with a Static Route to an HSRP Address?

Document ID: 13783

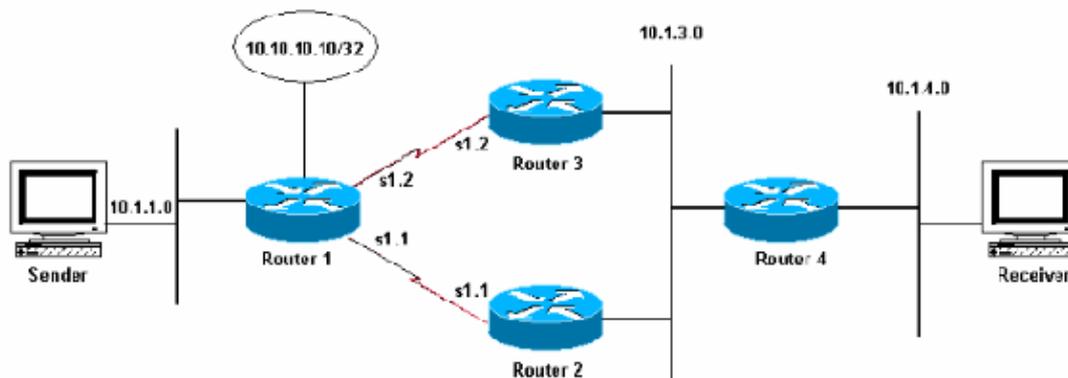
Network Diagram

In the figure above, Routers 2 and 3 are talking HSRP on subnet 10.1.3.0, and Router 2 is the active router. Routers 1, 2, and 3 are talking Enhanced Interior Gateway Routing Protocol (EIGRP), and Router 4 has a static default route to the HSRP virtual address.

Because there is a receiver for this group (due to the **ip igmp join-group** command used in Router 4), build a (*,G) entry in the mroute table. Note the Reverse Path Forwarding (RPF) neighbor for the (*,G) entry is 10.1.3.3, which is the HSRP standby address. However, there is not a (S,G) entry, which means traffic is not being received from the source.

In the example, the RPF neighbor is 10.1.3.3, which is the HSRP standby address used by the default static route. However, this address is not listed as a PIM neighbor. The reason the HSRP standby address is not listed as a PIM neighbor is because the two routers running HSRP (Routers 2 and 3) will not source the PIM neighbor messages from the HSRP standby address.

To solve the problem, change Router 4's configuration so the RPF neighbor is also a PIM neighbor. Do this by including Router 4 in the EIGRP process so that it now learns the RP address through EIGRP.

Note: Instead of including Router 4 in the EIGRP process (the preferred method), add static mroutes to Router 4 to make it RPF to the real routers' IP addresses because mroutes are preferred over the unicast routing table in RPF checks. For example, add **ip mroute 0.0.0.0 0.0.0.0 10.1.3.2**.
