Troubleshoot IP Multicast Guide

[Introduction](#)

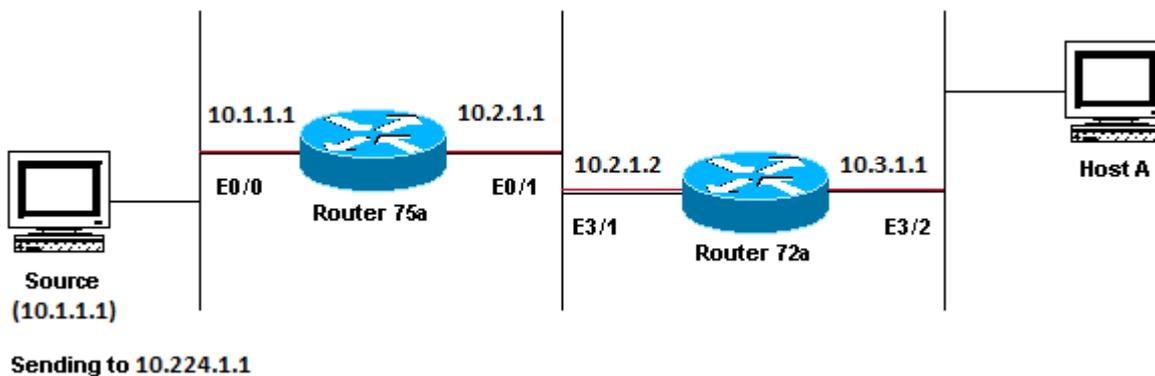
Network Diagram Example of Multicast RPF Failure

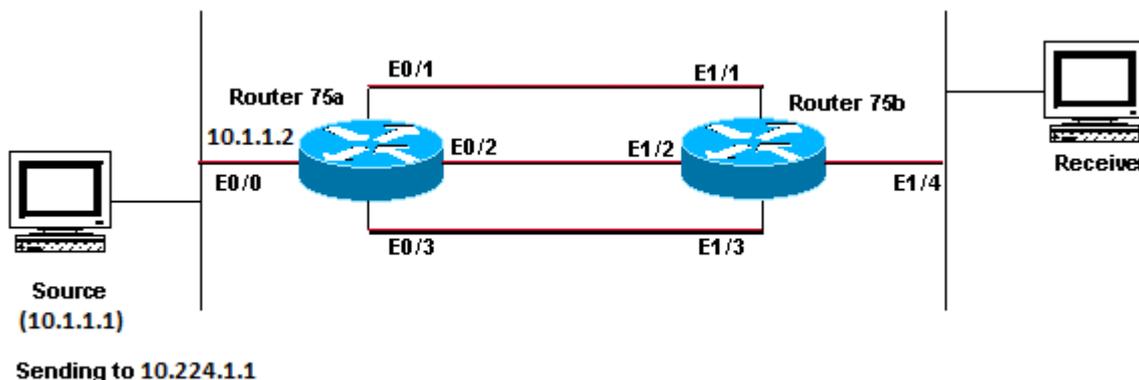
Equal Cost Paths to a Multicast Source Causes Unwanted RPF Behavior

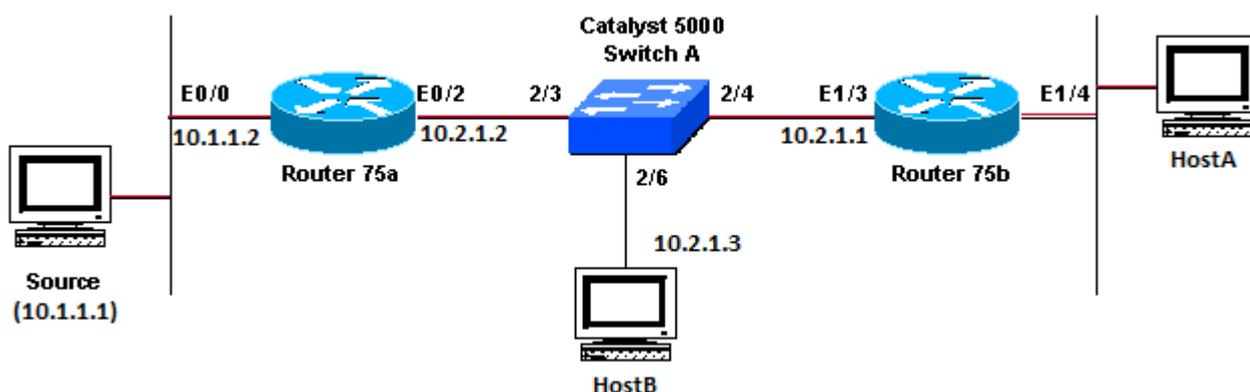
Add a Host to the Same VLAN as Routers 75a and 75b
