Troubleshoot Open Shortest Path First Neighbors Stuck in Exstart/Exchange State

This document describes how to troubleshoot situations in which Open Shortest Path First (OSPF) neighbors are stuck in Exstart and Exchange states.

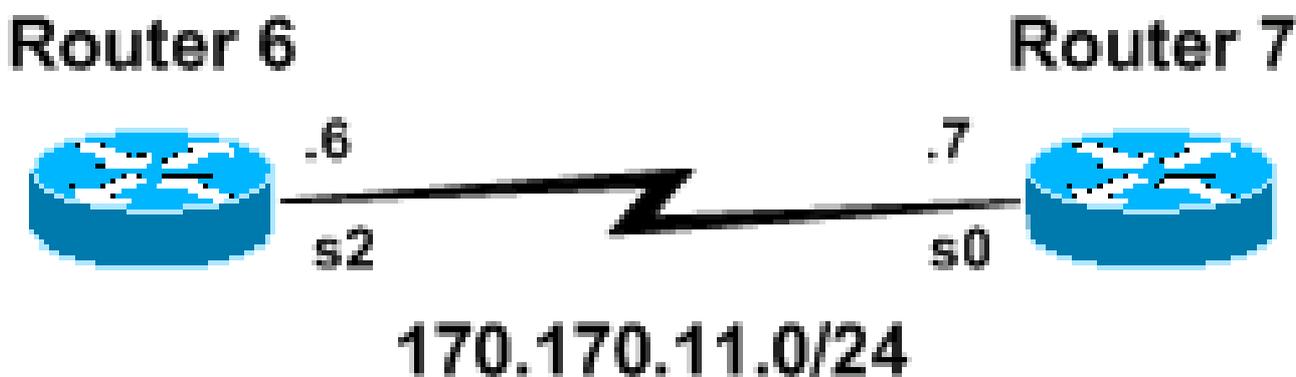
Router 6 and Router7 Connect via Frame Relay

Router 6 and Router 7 in this figure are connected via Frame Relay and Router 6 has been configured with 5 static routes redistributed into OSPF. The serial interface on Router 6 has the default MTU of 1500, while the serial interface on Router 7 has an MTU of 1450. Each router configuration is shown in the table (only necessary configuration information is shown):

Router 7 never gets an ACK from Router 6 because the DBD packet from Router 7 is too large for the Router 7 MTU. Router 7 repeatedly retransmits the DBD packet.

Since the problem is caused by mismatched MTUs, the solution is to change either router MTU to match the neighbor MTU.

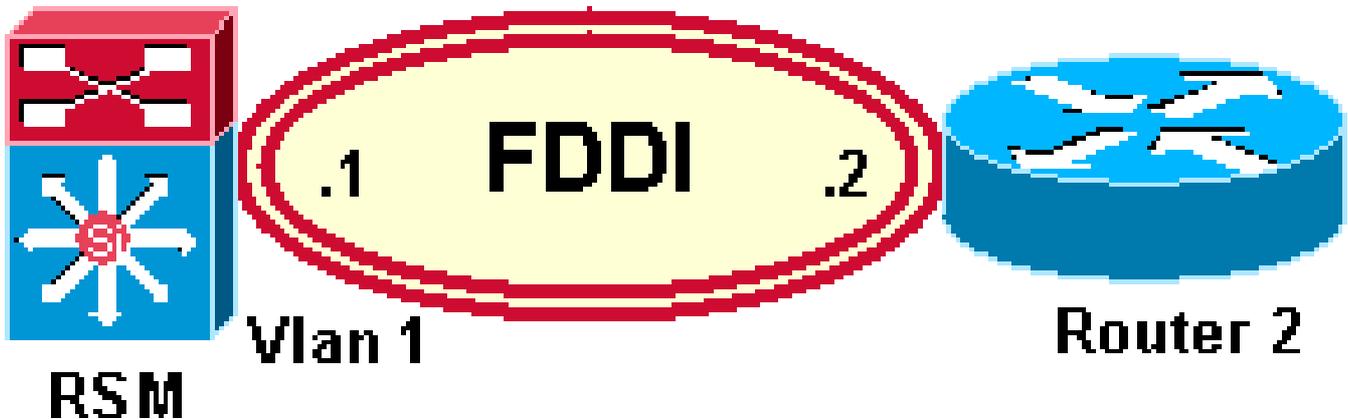
Fiber Distributed Data Interface (FDDI) Port

The previous diagram shows a Fiber Distributed Data Interface (FDDI) port on a Cisco Catalyst 5000 with a Route Switch Module (RSM) connected to a FDDI interface on Router 2. The Virtual LAN (VLAN) on the RSM is a virtual Ethernet interface with a MTU of 1500, and the FDDI interface on Router 2 has a MTU of 4500. When a packet is received on the FDDI port of the switch, it goes to the backplane and the FDDI to Ethernet conversion/fragmentation happens within the switch itself. This is a valid setup, but with MTU mismatch detection feature, OSPF adjacency is not formed in between the router and the RSM. Since FDDI and Ethernet MTU are different, this **ip ospf mtu-ignore** command is useful on the VLAN interface of the RSM to stop OSPF detection of MTU mismatch and forms the adjacency.

In Cisco IOS Software 12.01(3), the **ip ospf mtu-ignore** interface configuration command was also introduced to turn off the MTU mismatch detection; however, this is only needed in rare instances, as shown in this diagram:
