# **Troubleshoot MAC Flaps/Loop on Cisco Catalyst** Switches

This document describes how to troubleshoot the MAC Flaps/Loop on Cisco Catalyst Switches.

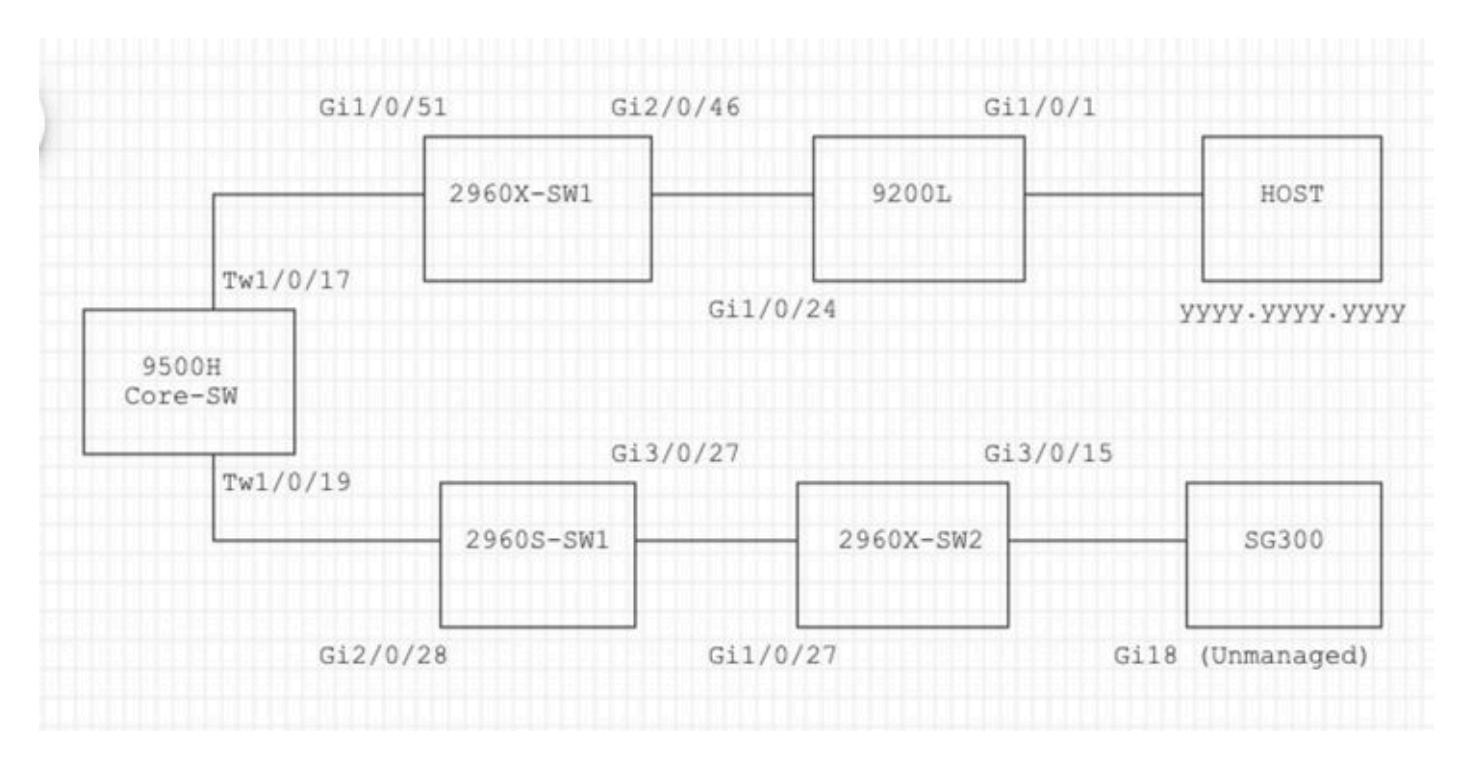
### Topology

Some of the servers are either inaccessible or experiencing significant latency/drops.

1. Noticed MAC flapping occurring on the Core switch.

(Appears to be a loop path.) The port on the Core-SW was shut down in order to mitigate the loop.

MAC flaps were seen due to the SG300 (unmanaged) switch connected to the network.

The MAC flapping issue was resolved by shutting down the port connected to the unmanaged switch SG300.
