10000 ESR PRE2 Parity Error Fault Tree

Document ID: 44228

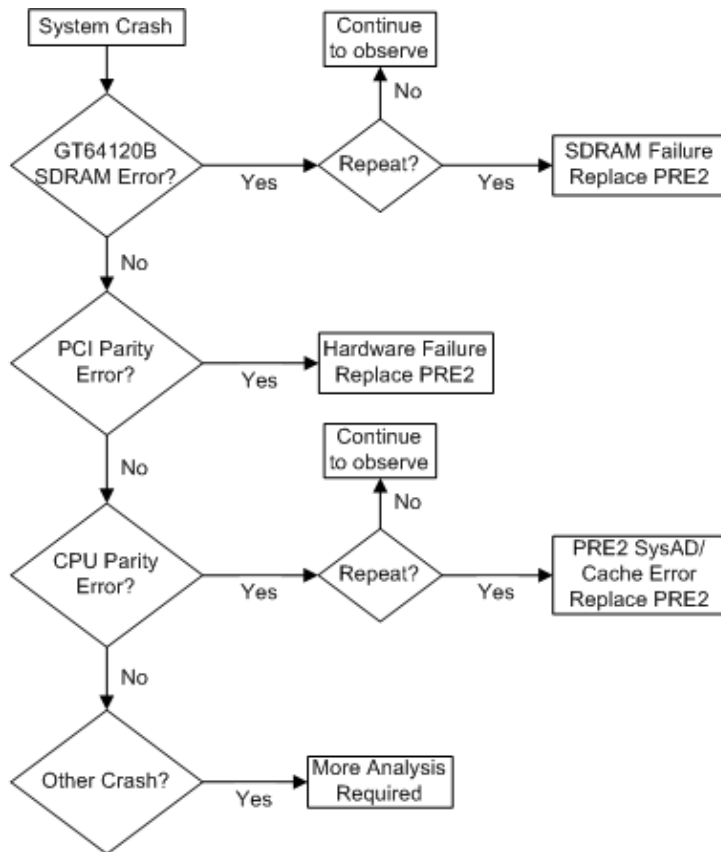
The Cisco 10000 Series ESR PRE2 consists of two circuit cards: the Route Processor (RP) and the Forwarding Processor (FP). The flowchart below can help you determine which component of an ESR PRE2 is responsible for parity or Error-Correcting Code (ECC) error messages on the route processor.

Note: Capture and record the **show tech-support** command output and console logs, and collect all crashinfo and pxf_crashinfo files during parity or ECC error events.

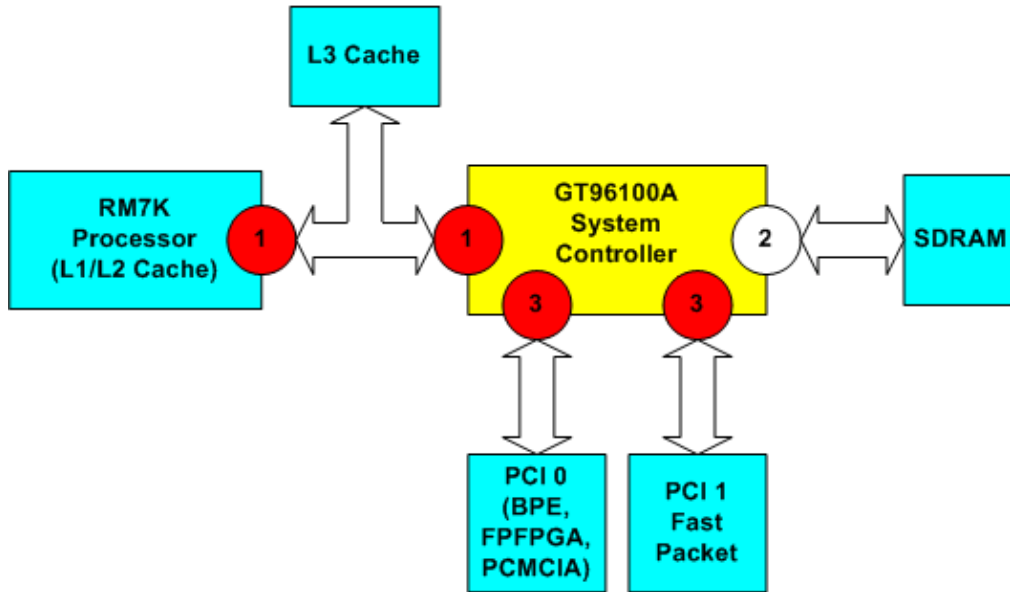
The red circles indicate paths where the PRE2 will detect parity.
 The white circle indicates the path where single-bit errors will be detected and corrected.

- 1** CPU Parity Error (Cache, Bus Exception)
- 2** SDRAM
Correct single-bit errors (SBEs)
OR
Detect multi-bit errors (MBEs)
- 3** PCI Parity Error

The PRE2 RP uses single-bit error (SBE) correction and multi-bit error (MBE) detection ECC to shared memory (SDRAM). An SBE in SDRAM is corrected automatically, and the system continues to operate as normal.

An MBE in SDRAM is a fatal event, which causes a cache error exception or bus error to occur. The rest of the memory and buses in the system use single-bit parity detection. SBEs at 1 and 3 in the diagram above are fatal and cause the router to reset.

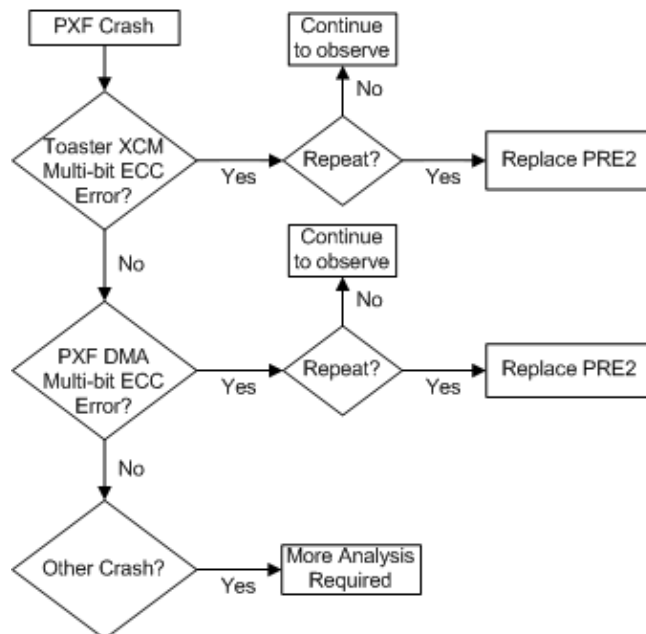
The following diagram helps you determine which component of a Cisco 10000 Series ESR PRE2 FP is responsible for ECC error messages:
