Troubleshoot PBB-EVPN ESI, ES Import RT and Source MAC Mismatch on ASR 9000

This document describes how to troubleshoot Ethernet Segment Identifier (ESI), Import Route Target (Import RT) and Source MAC mismatch in PBB-EVPN multi-homed networks (MHN).

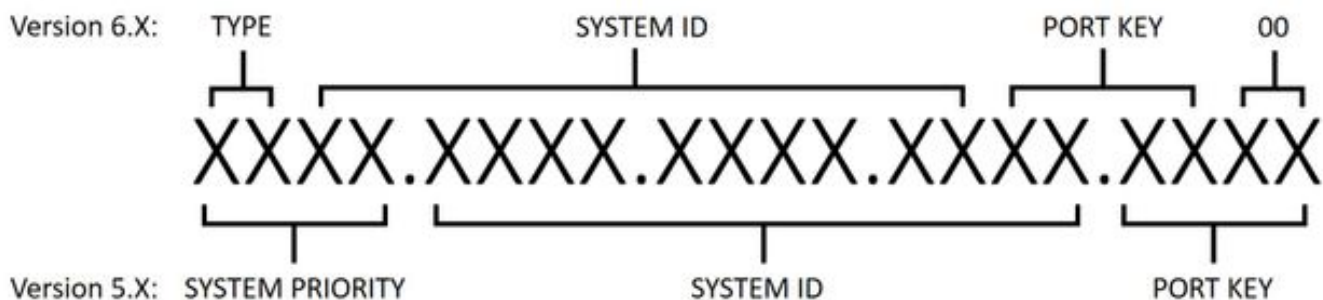
Starting from ASR 9000 version 6.0, PBB-EVPN ESI format is changed to be RFC 7432 compliant. This means ESI auto-sensing cannot work between a PE running on 6.X and a PE on previous versions.

This diagram shows how the default ESI is generated for version 6.X and older versions.

Run **show evpn ethernet-segment detail** to check if the default ESI matches on all PEs. If not,

manually configure ESI.

When configuring ESI, different software versions have different requirements. To meet these requirements, it is recommended to change ESI on all devices.

- In version 6.X the first byte is always TYPE(00) so only the other 9 bytes are configurable.
- In version 5.X all fields are configurable, but "system ID" field requires that the multicast and admin bits are set to 1.
