Troubleshoot Multicast Traffic Not Passing through FTD Firewall with Bidir PIM Configuration

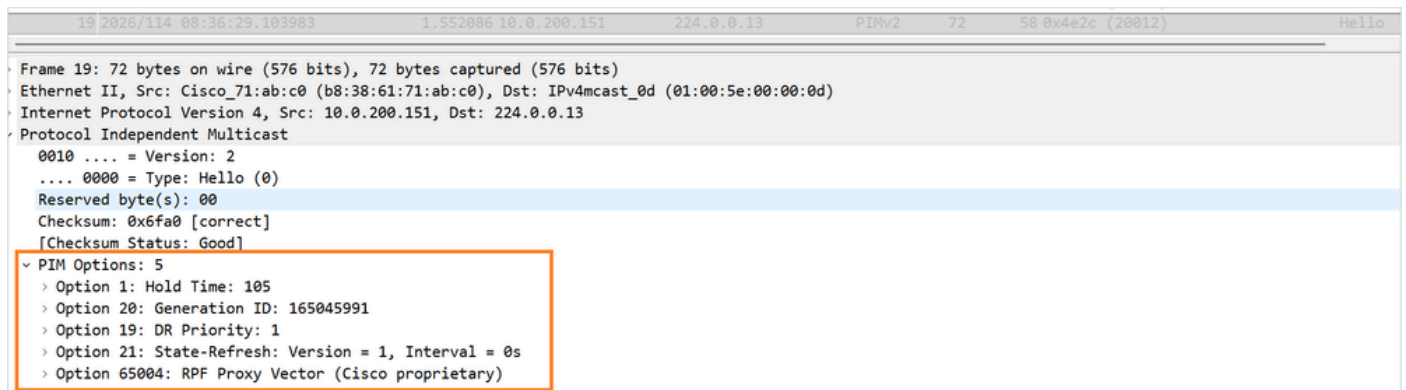
PIM_Hello_Options_no-bidir-capable.png

The PIM Hello packet contains these options:

Notice the absence of the Bidir-capable flag.

Step 7: Enable bidirectional PIM on the 10.0.200.151 neighbor.

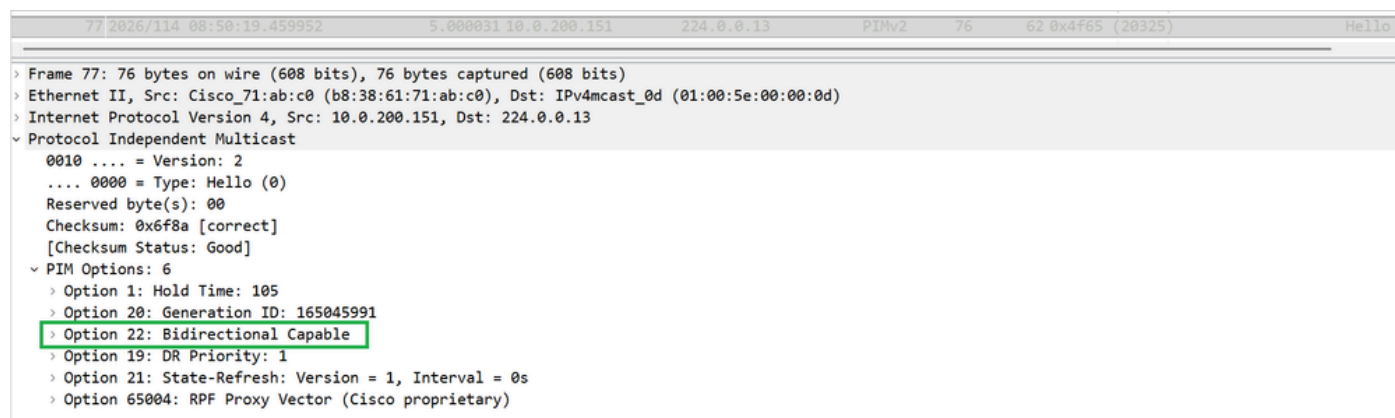
PIM_Hello_Options_option22.png

Step 8: Collect a new capture and check the PIM Hello options for neighbor 10.0.200.151. PIM option 22 (Bidirectional Capable) is shown:
