Troubleshoot Common Issues during Migration of 6200 Series to 6454 Fabric Interconnect

This document describes information to troubleshoot FI 6200 to 6400 series migration issues.

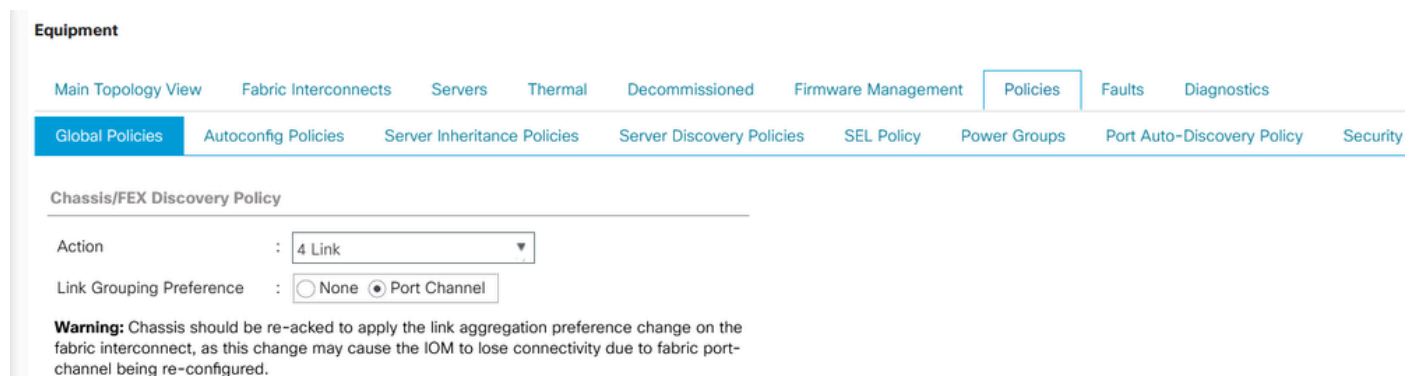
- Migration fails due to UCS manager version not upgraded to 4.0(1) or above. Cisco UCS Manager Release 4.0 is the bare minimum version that provides support for Cisco UCS 6454 Fabric Interconnects.
- Migration Warnings page will report the incompatibility if the chassis discovery policy is not set to “port channel” mode. UCS 6200 Series Fabric Interconnects support blade server chassis discovery in Port Channel and non-Port Channel modes. Cisco UCS 6400 Series Fabric Interconnects support only Port Channel mode.

Warning: Chassis should be re-acked to apply the link aggregation preference change on the fabric interconnect, as this change may cause the IOM to lose connectivity due to fabric port-channel being re-configured.

Change the chassis discovery policy > link grouping preference to “port-channel” and re-acknowledge the chassis to save the change. To avoid the re-discovery of entire chassis and to avoid taking a downtime, re-acknowledgment of one IOM at a time of given chassis can be done to re-discover the connectivity between IOM and fabric interconnect.

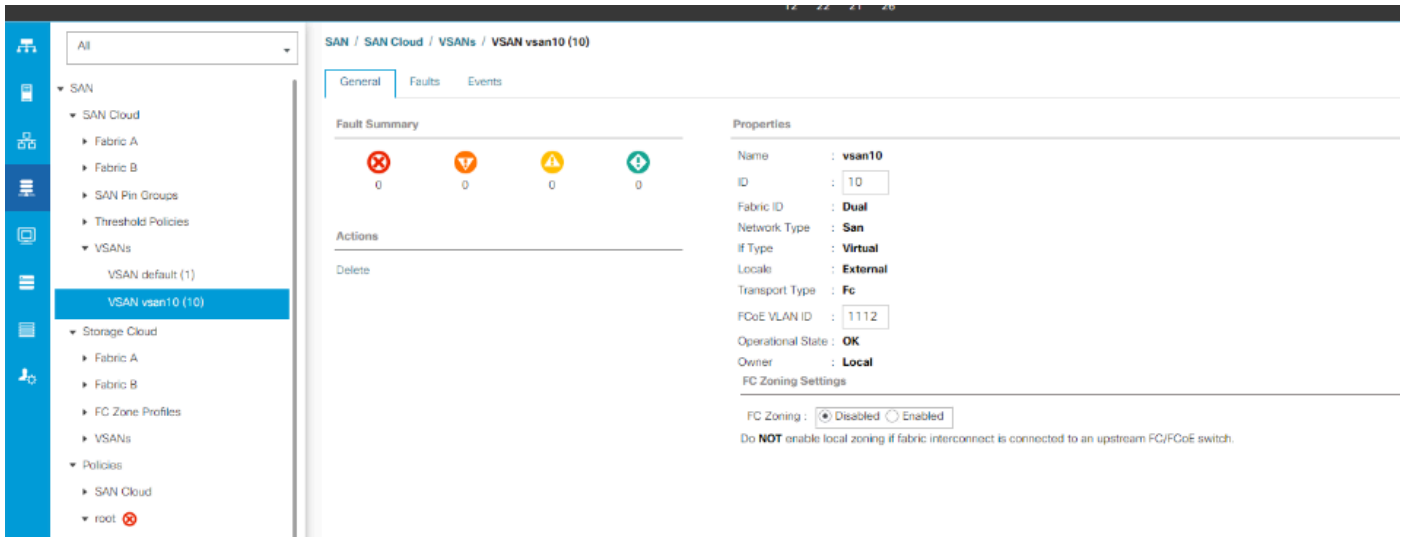
Cisco UCS 6400 Series Fabric Interconnects reserve more VLANs for internal use than UCS 6200 Series Fabric Interconnects. If there are conflicting VLANs, after migration the Reserved VLAN range will be configured but VLANs found in the conflicting range will not be configured.

Note : You cannot create VLANs with IDs from 3968 to 4047 and 4092 to 4096. These ranges of VLAN IDs are reserved.

Check the FCOE VLAN ID set for VSAN configured on FC interfaces. If they are within the range of reserved VLAN, the ports will fail to come up.

- Use the VLAN ID outside the reserved VLAN range.
- Modify the Reserved VLAN through CLI or UCSM GUI (Changing the reserved VLAN requires a reload of the Cisco UCS 6400 Series Fabric Interconnect for the new values to take effect). Refer to the network guide to execute the change.
