# Understanding and Troubleshooting Astro/Lemans/NiceR Timeouts on Catalyst 4000/4500 Series Switches

Document ID: 45640

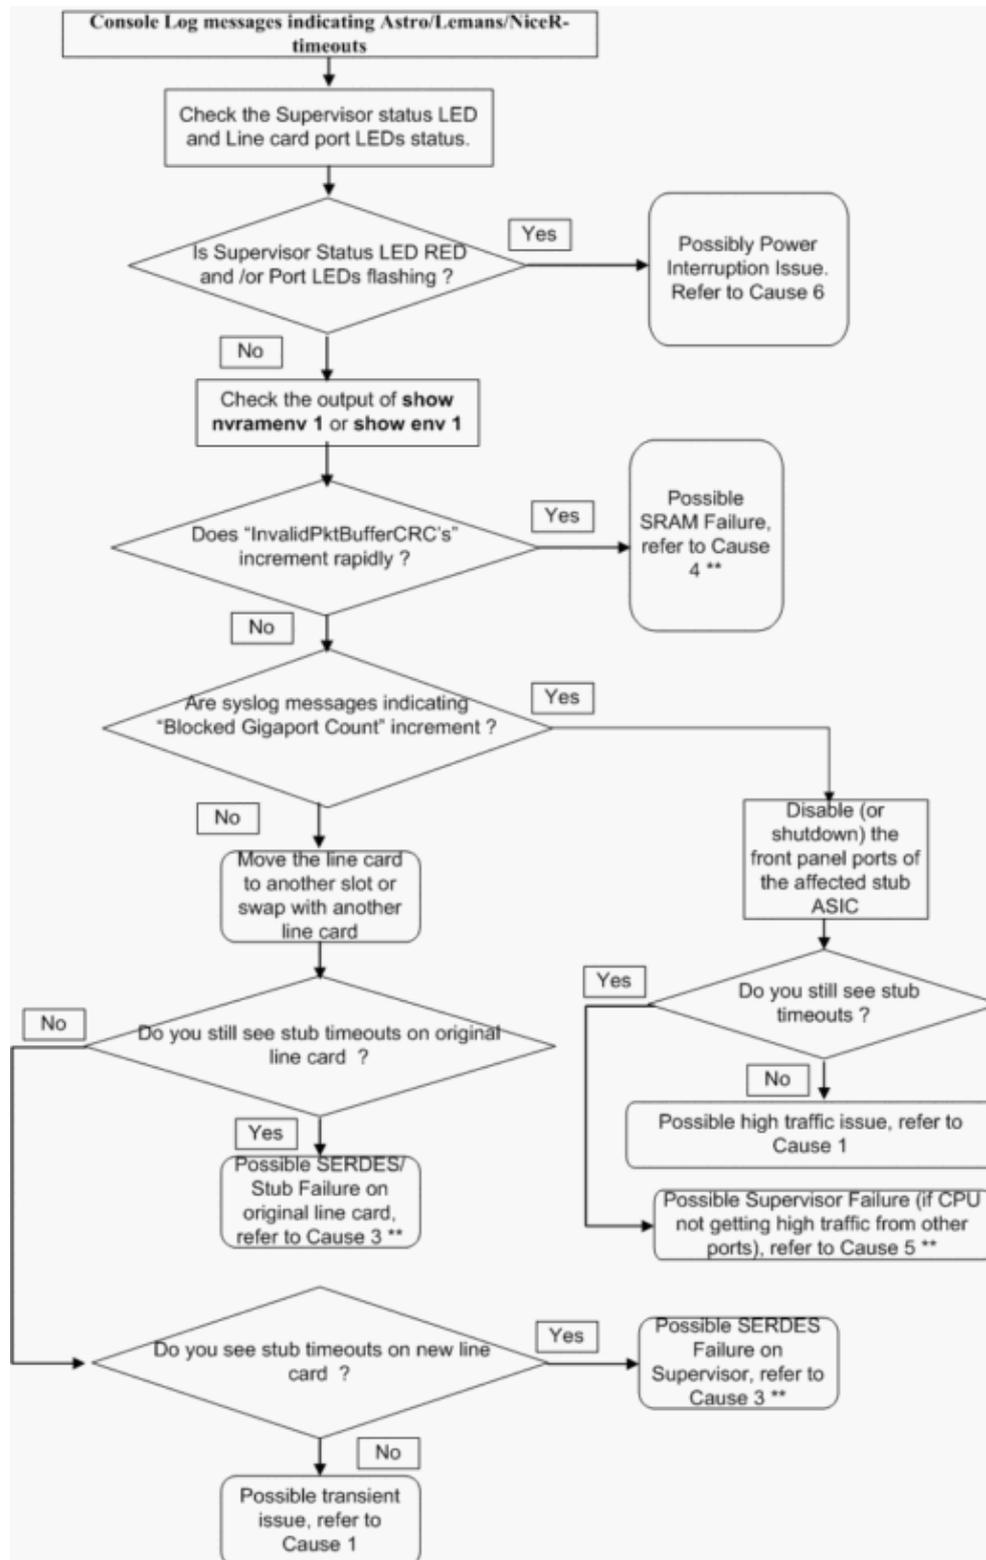
The following troubleshooting flowchart presents a quick and easy way to isolate the problem between the

possible root-causes:

\*\* Various root causes may exhibit similar symptoms. Please contact TAC for further troubleshooting.
