Understanding and Troubleshooting Astro/Lemans/NiceR Timeouts on Catalyst 4000/4500 Series Switches

Document ID: 45640

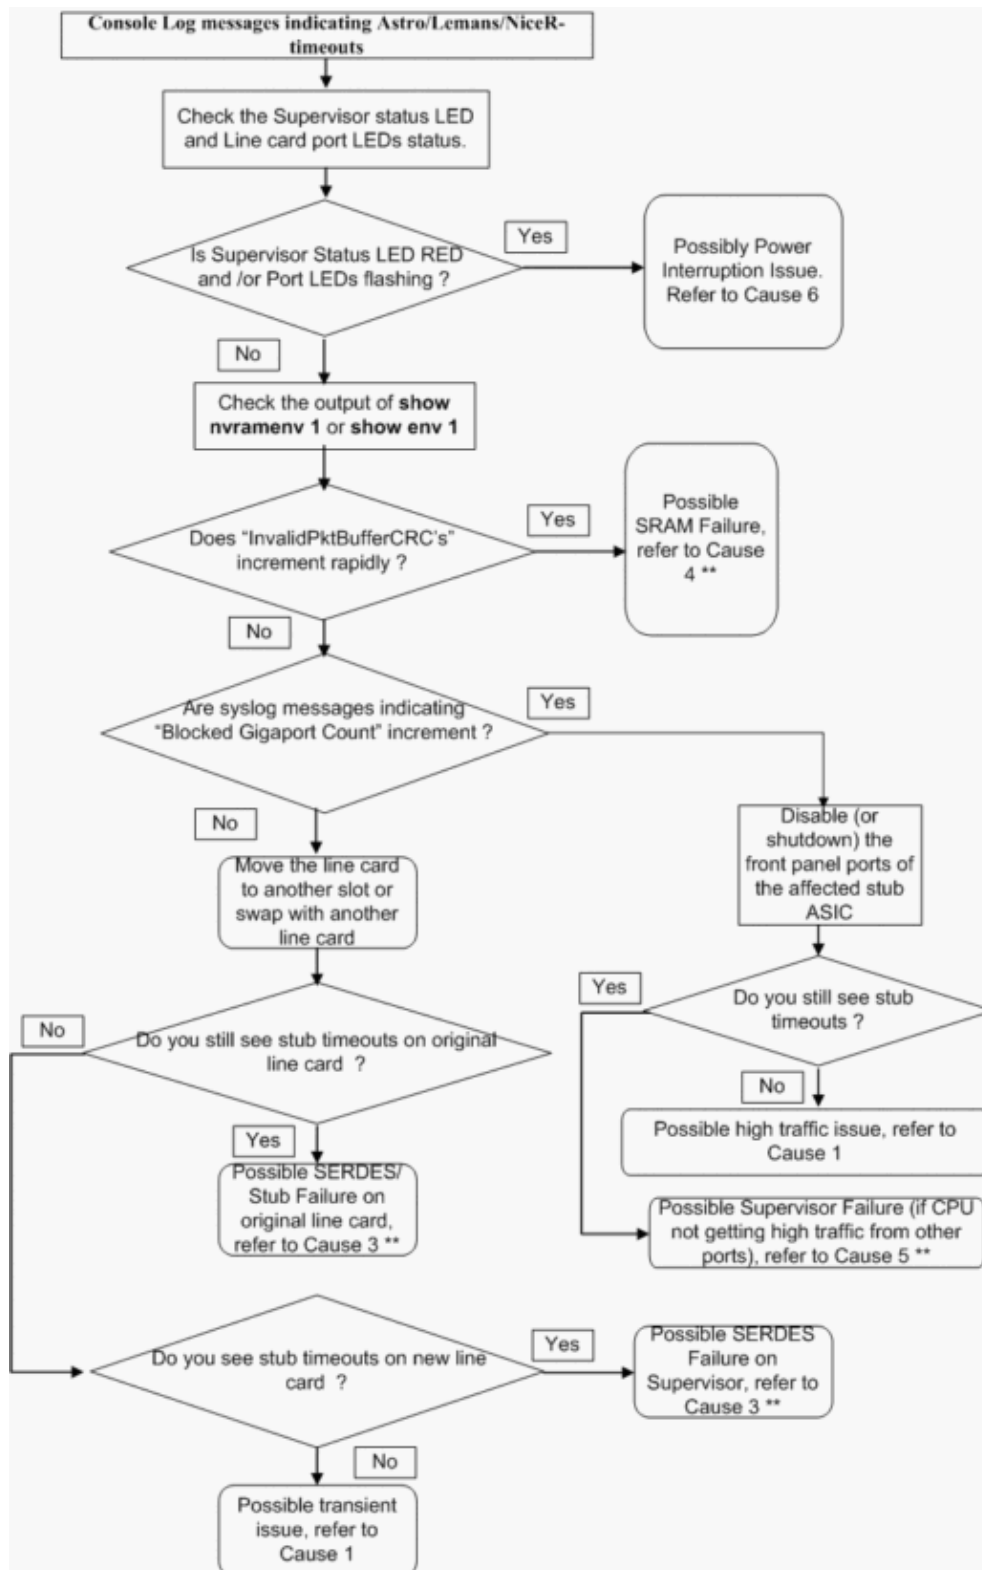
The following troubleshooting flowchart presents a quick and easy way to isolate the problem between the

possible root-causes:

** Various root causes may exhibit similar symptoms. Please contact TAC for further troubleshooting.
