Troubleshoot Unknown Protocol Drops in Catalyst 9000 Switches

This document describes common causes for unknown protocol drops in Catalyst 9000 series switches.

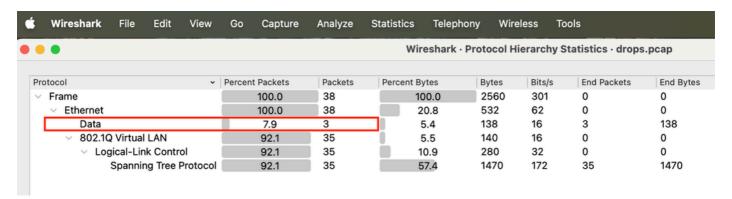
Step 9. Expand the protocol tree and verify that the switch interface is configured for these protocols. Anything labeled as **Data** causes unknown protocol drops because the ethertype is unknown.

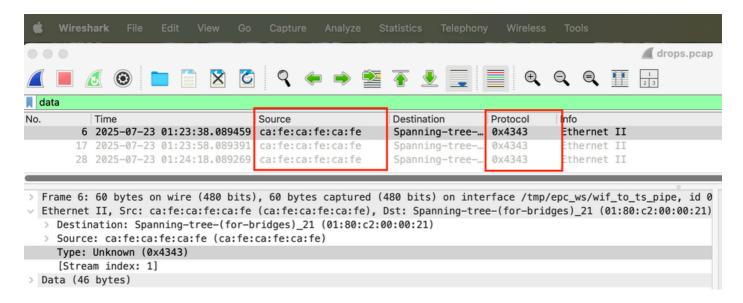
Step 11. Go back to Wireshark's main window to determine source MAC address and ethertype for unknown protocols.

In this case, source MAC address CAFE.CAFE is causing unknown protocol drops because ethertype 0x4343 is unsupported.
