Troubleshooting Network Latency and Packet Drops on Catalyst 9000 Switches

This document describes a detailed methodology for troubleshooting network latency and packet loss issues on Cisco Catalyst 9000 Series switches.

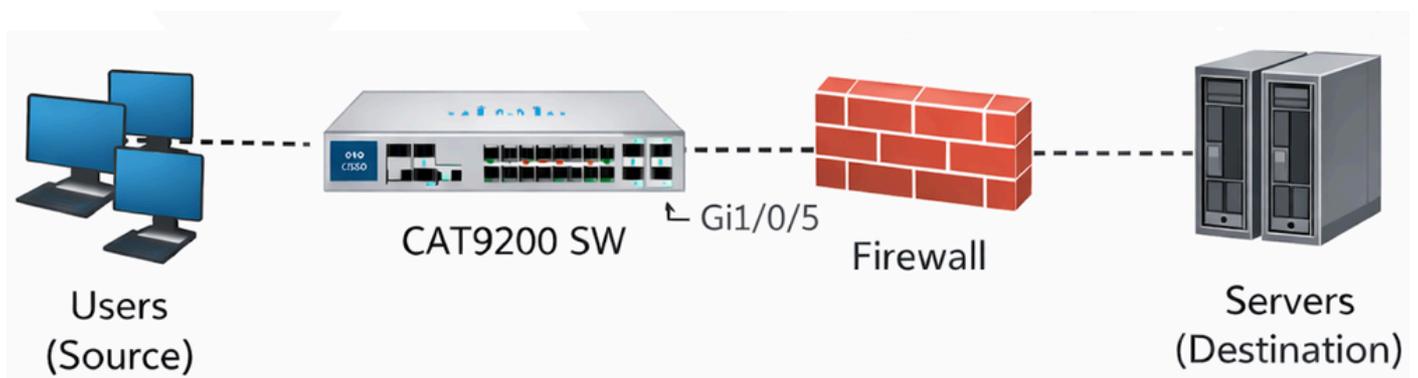
Topology

Users are experiencing intermittent network connectivity loss during attempts in order to transfer large volumes of data across vLANs, such as during high-capacity file transfers. These disruptions manifest as sporadic failures in data transmission despite multiple successful attempts, significantly impacting network reliability and application performance. The issue is temporarily resolved by reloading the switch.

- File transfers between the source and destination intermittently fail after several successful attempts.
- The switch loses connectivity to the firewall during failure periods.

- 802.1X authentication remains operational throughout the incidents.
- The switch remains responsive via the console during the incidents.
- The connected port of the firewall shows only broadcast traffic during failure periods.
- Diagnostic tests (DiagGoldPktTest) consistently fail on interface Gi1/0/5, indicating a data path issue.

The root cause was identified as buffer lockup due to excessive 802.3x pause frames sent by the Firewall to the switch interface. Ethernet pause frames instruct the switch to stop transmitting in order to allow the receiving device to recover from congestion. However, when pause frames are sent repeatedly or for extended durations:

The intermittent network connectivity failures and packet drops between the Cisco C9200L switch and Firewall were caused by a software queue lockup triggered by an excessive volume of 802.3x pause frames. Disabling input flow control on the switch interface resolved the issue by preventing the queue from becoming saturated and locked.
