# SRW Switches: Fix Microsoft IE8 Browser Problems

Document ID: 111063

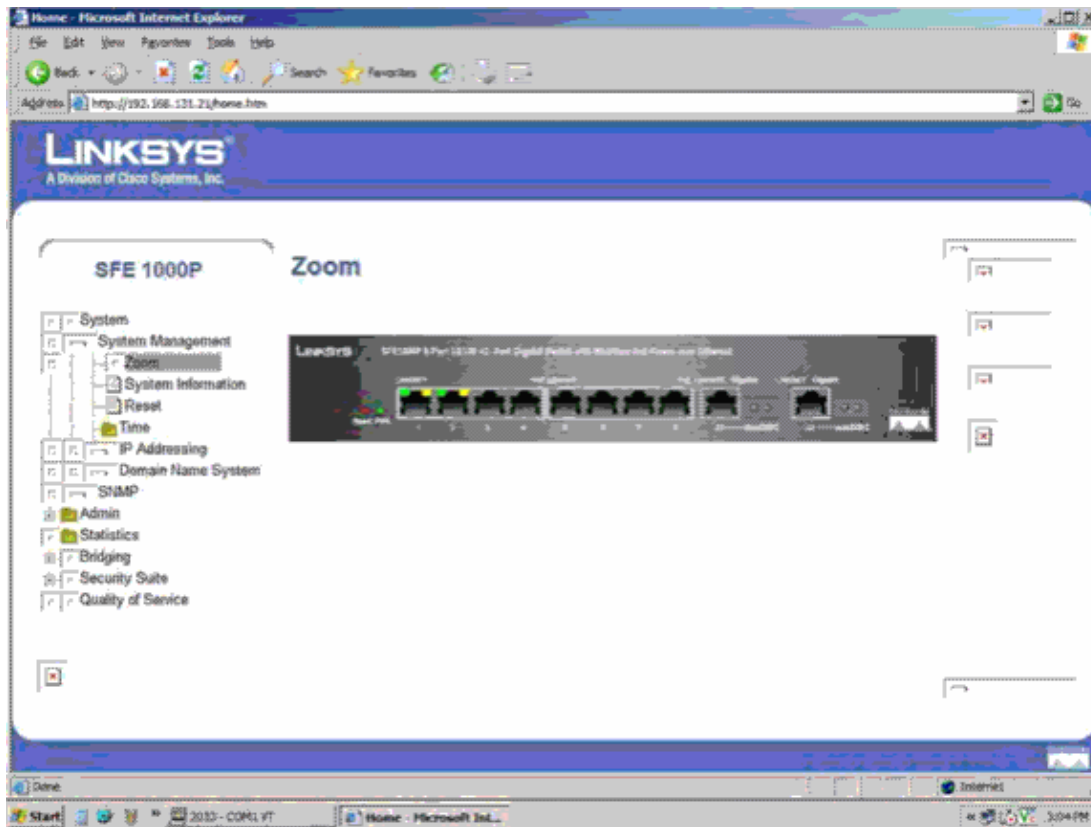
**Figure 1**

If the page does not display completely when you use Internet Explorer 8 to manage Cisco Small Business SRW Switches, as shown in Figure 1, complete these steps:

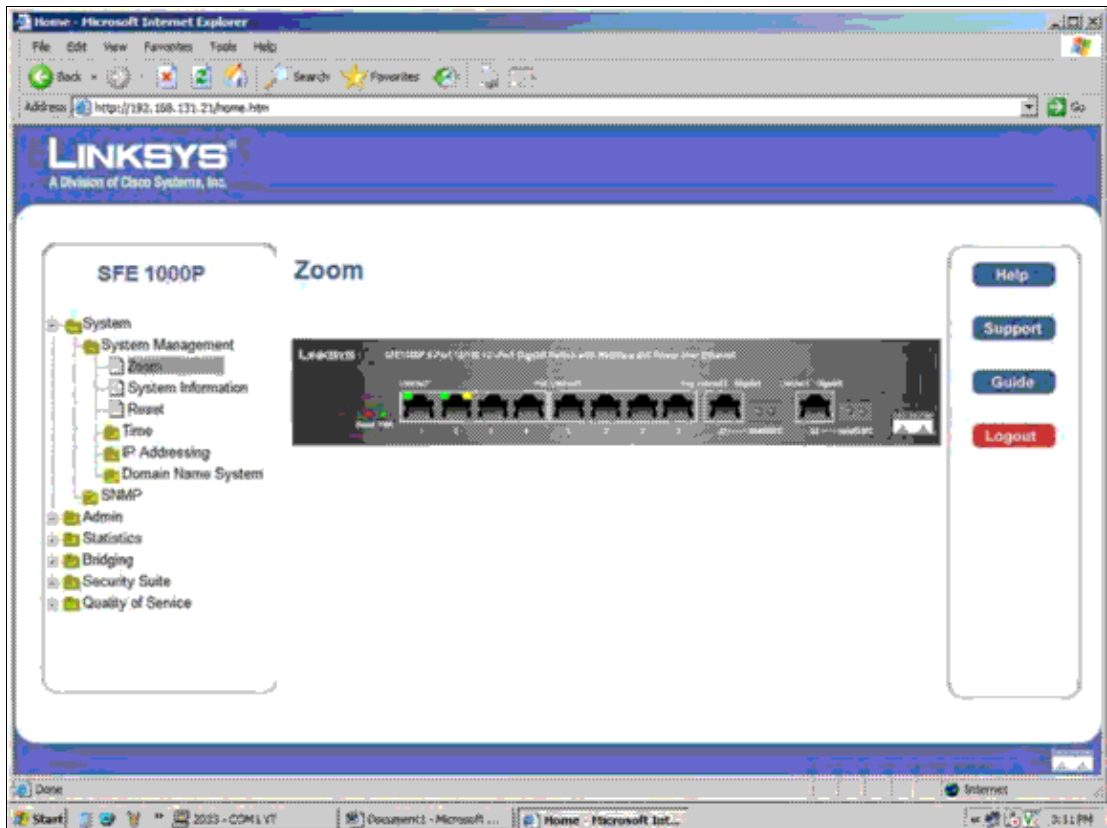
Figure 4

3. Access the switch again, and the problem is fixed, as shown in Figure 4.
