Troubleshoot APIPA Address Failure in the Network

This document describes the issues related to APIPA addresses and provides resolutions for the same.

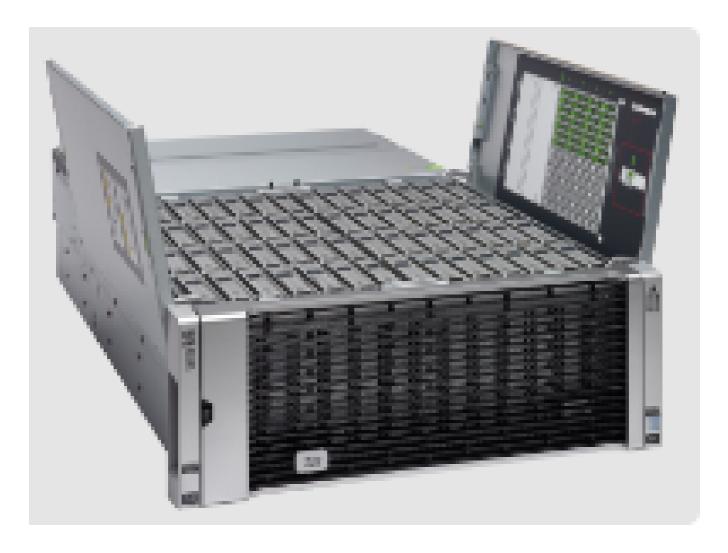
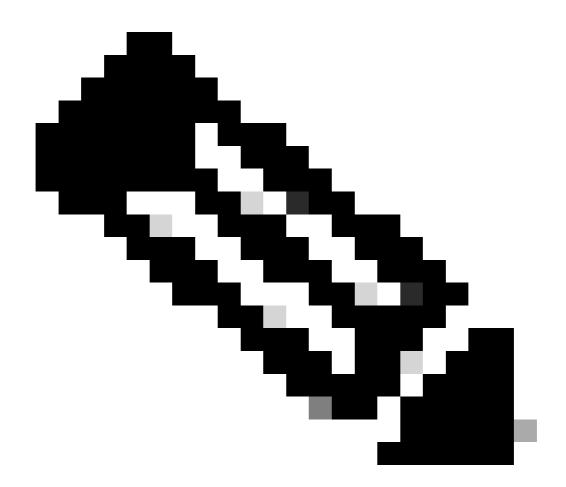
Scenario 2 - DHCP server scope

• User machines recieve APIPA IP address and user connectivity impacted.

1. Users on specific vlan gets only APIPA IP address and lose connection to network.

• DHCP server assigns one ip address from scope A and same ip address being assigned to another Laptop because scope B has same range. This causes DHCP decline:

• Assign unique DHCP scope range

• End devices receive IP address after scope change.

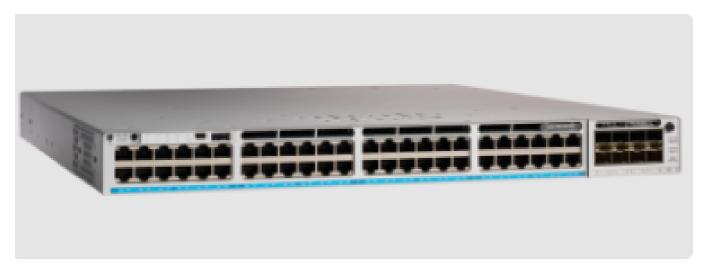
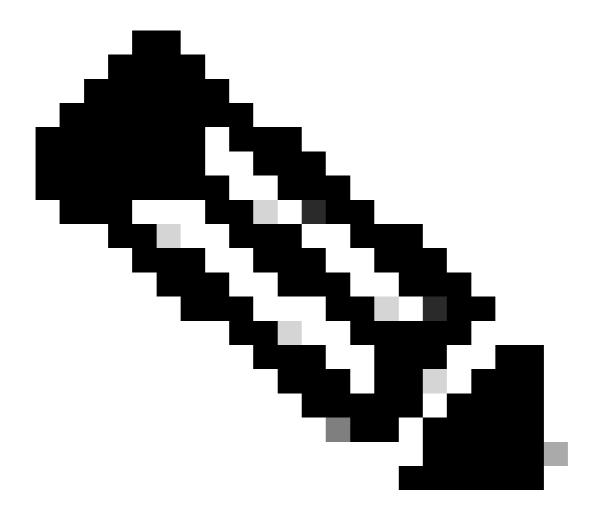
Scenario 3 - C9300 SDA configuration

• User machines recieve APIPA IP address and user connectivity impacted.

- 1. Some users in a specific VLAN are not able to obtain DHCP addresses through the wireless AP.
- 2. Firewall had multiple arp entries for a single end user mac address

- DHCP Offer was dropped by switch
- FTD populate ARP based on DHCP OFFER coming back from DHCP server.

• If L2-only VLAN is configured for SDA wireless setup, offer packet with broadcast flag do not reach AP. Since Access-tunnel doesn't allow broadcast packets by default.

• Allow "flood capability" inside LISP environment.

• After configuring `flood access-tunnel` in the C9300 connected on inside interface, clients receive DHCP addresses.

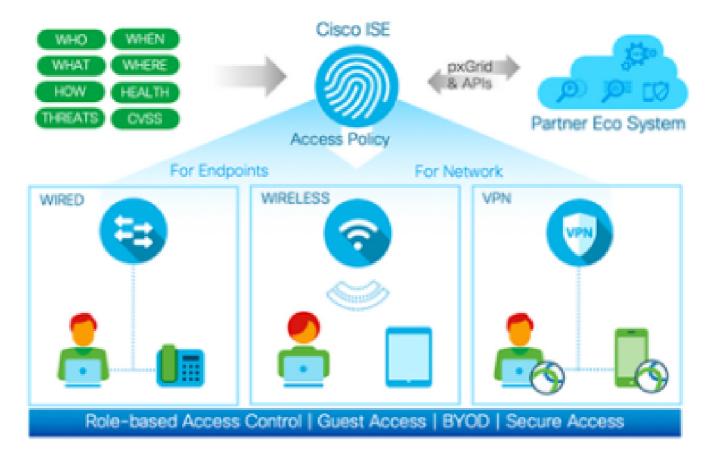
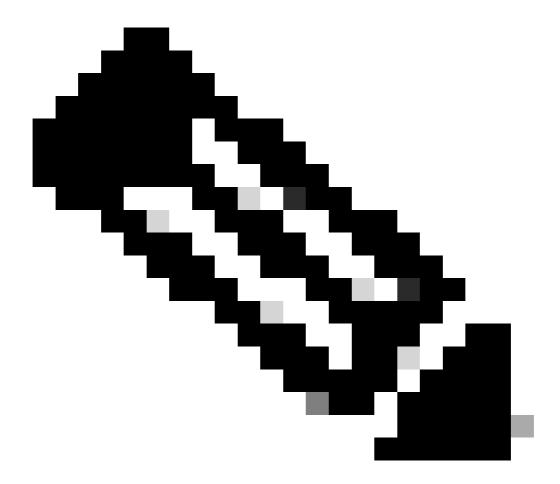
Scenario 4 - LAN Adaptor problem

• User machines recieve APIPA IP address and user connectivity impacted.

1. Mac address-table shows entries with "drop".

2. The Show Authentication session shows many entries, possibly exceeding 2000 or even 10000.

This is an indication of end user Adaptor problem. This sends malformed packets which the switch understands as Random source mac addresses.

- Configure "authentication host-mode multi-domain" which allows only 2 mac addresses.
- Identify and isolate the culprit device.

After configuring this workaround no issue be observed.
