# Troubleshoot Upgrade Failure in Unity Connection 15 Due to Missing AVX CPU Instructions

This document describes how to troubleshoot dblinit-plugin generic Error on the Cisco Unity Connection upgrade from 15su2 to 15su4 on the Subscriber.

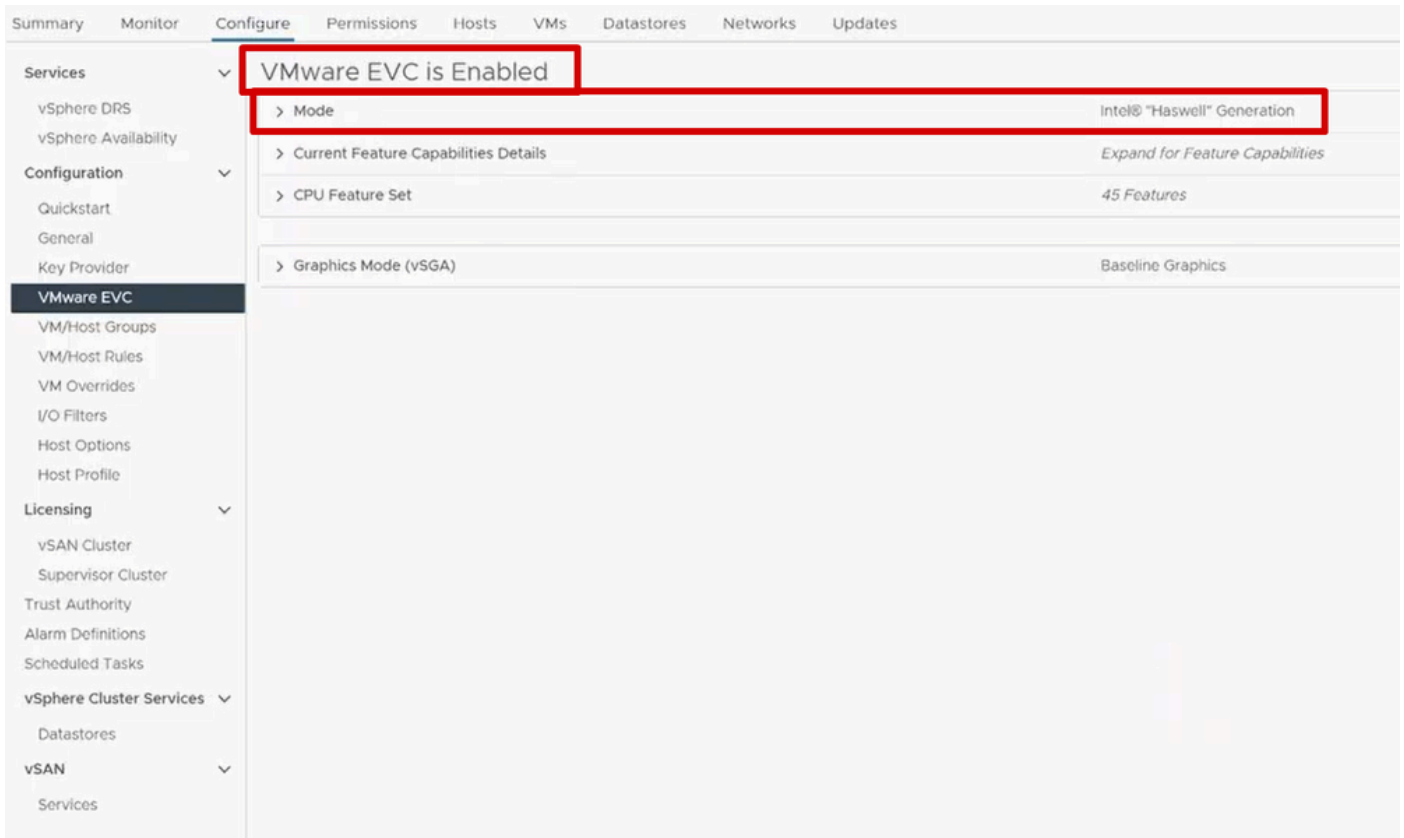
Verify the configured EVC mode. Intel "Westmere" generation and older do not support AVX exposure. The EVC mode must be set to a generation that supports the AVX (Sandy Bridge or newer one that depends on hardware generation).

*VMWare EVC is Enabled with Mode Intel Haswell*
