# ICM Drops Translation Route to IP IVR Calls

Document ID: 50582

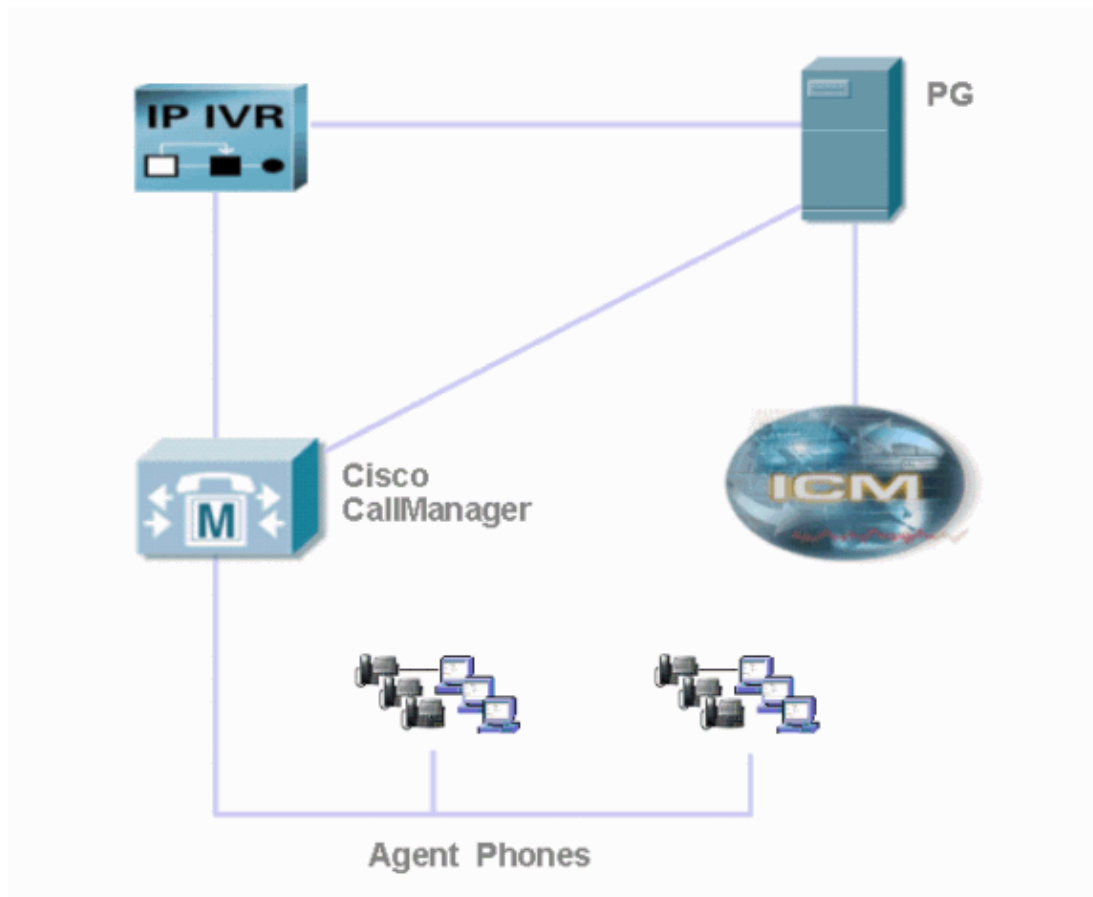
When the failure occurs, the topology is set up as shown here.

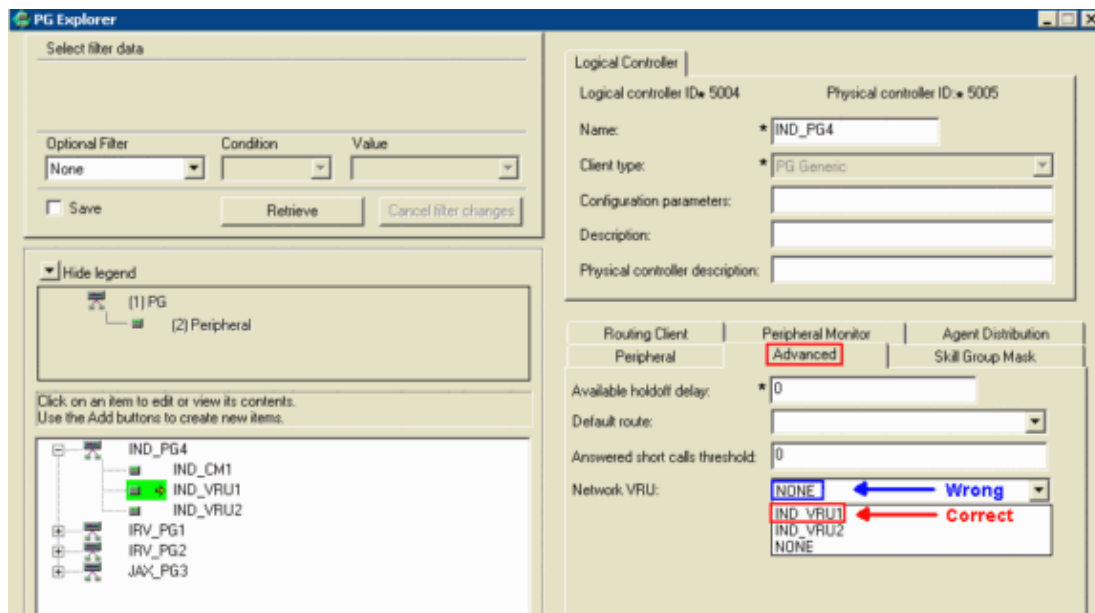
This is a configuration issue. View the rtr log file on the Router using the Dumplog utility, the following message appears:

```
15:20:51 ra-rtr Trace: TranRouteToVRU failed. Unable to map route 5009 to a network VRU
```

Verify the specific route, it is associated with a specific IP IVR. Check the configuration in PG Explorer, the **Network VRU** name is set to **NONE** instead of the name of this specific IP IVR under **Advanced**, as shown below. Select the right Network VRU name resolves this issue.
