Cisco Nexus 7000 Series NX-OS Release Notes, Release 6.1

Date: October 10, 2014
Part Number: OL-26854-06 E0
Current Release: 6.1(5a)

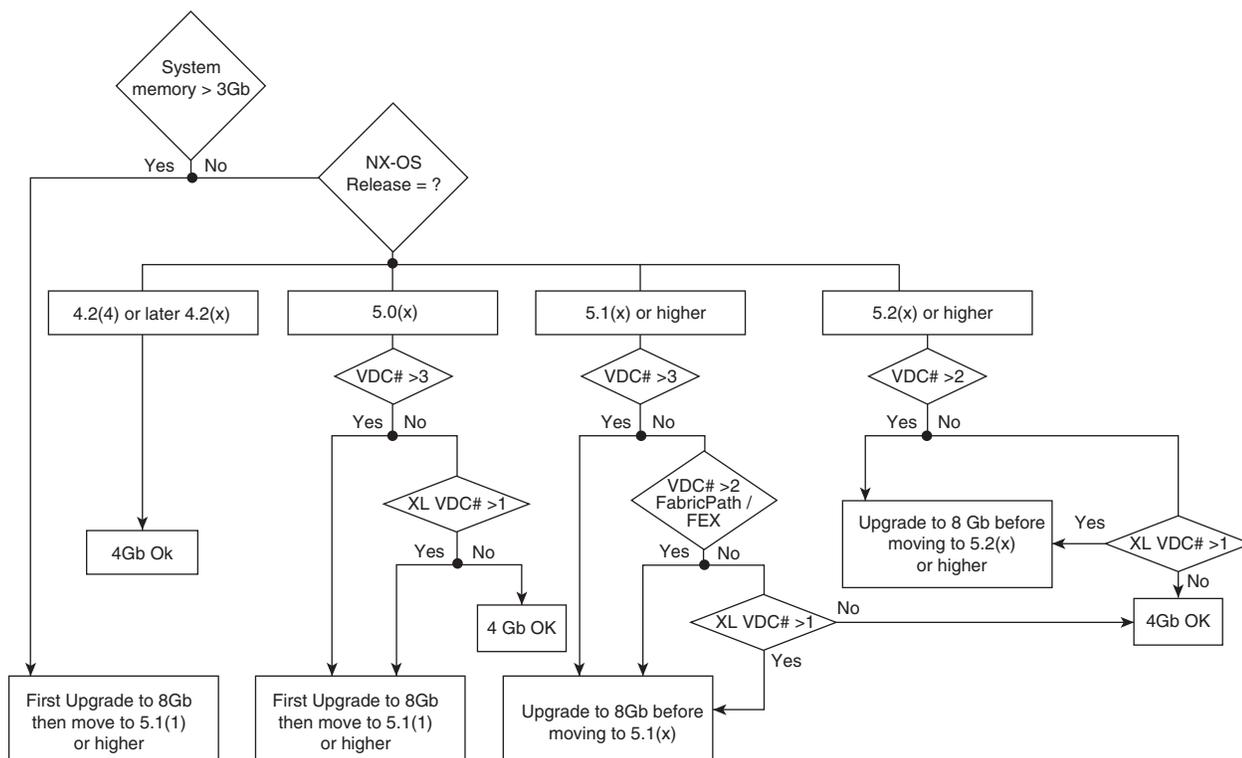
Figure 1 Supervisor Memory Upgrade Decision Flowchart

For additional guidance about whether or not to upgrade a supervisor module to 8 GB of memory, see [Figure 1](#).

- When the system memory usage exceeds 3 GB (75 percent of total memory), we recommend that you upgrade the memory to 8 GB. Use the **show system resources** command from any VDC context to check the system memory usage:
