Release Notes for the Cisco ME 3400 Ethernet Access Switches, Cisco IOS Release 12.2(25)SEG and Later

Revised September 24, 2008

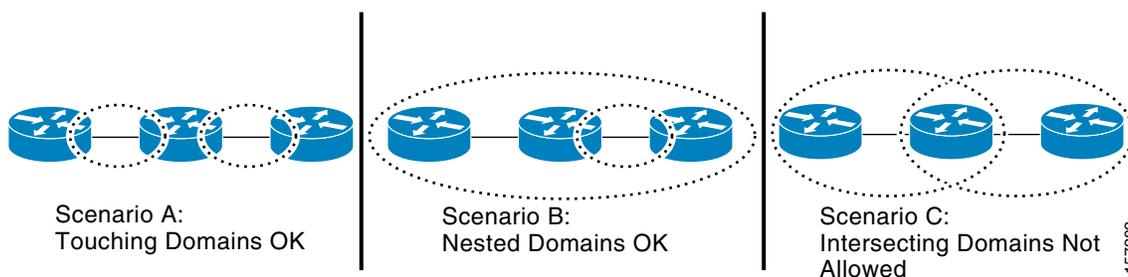
Figure 34-2 Allowed Domain Relationships

In Chapter 34, “Configuring Ethernet CFM and E-LMI,” Figure 34-2 originally showed incorrect examples for Scenario B and Scenario C. The illustration has been corrected as shown below:

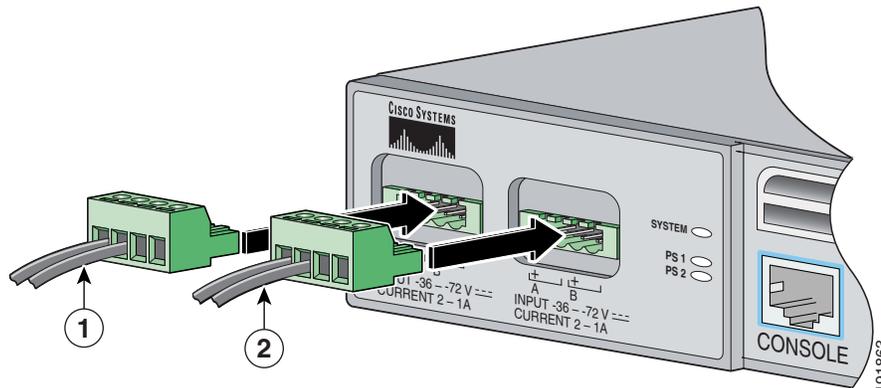
Figure 1 Connecting Separate Feeds to Each of the DC Power Terminal Blocks

This message means that an internal power supply is not providing power. To receive this alert if power fails on the ME 3400G-12CS-DC switch with two power feeds, we recommend that you connect one feed to the left DC power terminal block and the other to the right DC power terminal block. (See the example in [Figure 1](#).)

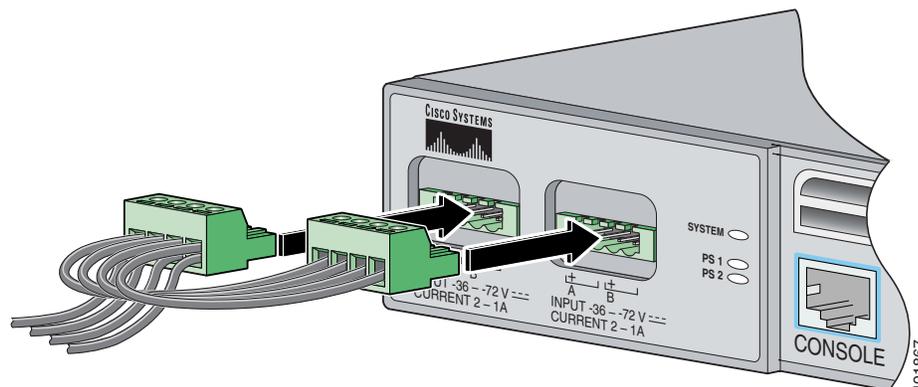
Figure 2 Connecting Feeds from One Terminal Block to the Second Terminal Block

If you want to receive an alert if an external power supply fails, do not connect feeds to one terminal block and from there connect feeds to the second terminal block. (See the example in [Figure 2](#).) This configuration provides redundant power, and the switch continues to operate if one of the external power supplies fails. However, the software does not send a message to you that an internal power supply has failed.
