Release Notes for Cisco Aironet 1200 Series Access Points

July 3, 2002

These release notes describe caveats for Cisco Aironet 1200 Series Access Points running firmware version 11.42T. This firmware release resolves bug CSCdx79987.

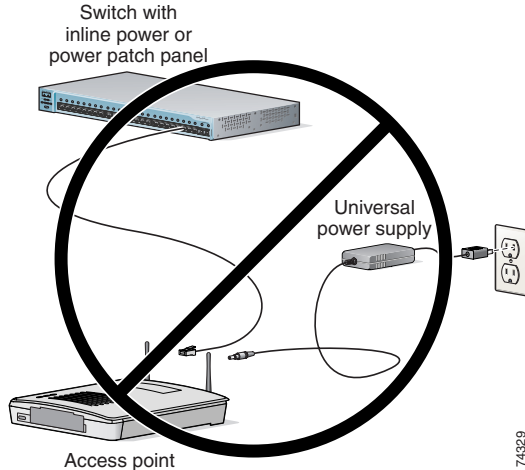
Figure 1 *Improper Power Configuration Using Two Power Sources*

You cannot provide redundant power to the access point with both DC power to its power port and inline power from a patch panel or powered switch to the access point's Ethernet port. If you apply power to the access point from both sources, the switch or power patch panel might shut down the port to which the access point is connected. [Figure 1](#) shows the power configuration that can shut down the port on the patch panel or powered switch.
