# Release Notes for Cisco Aironet Access Points for Cisco IOS Release 12.3(8)JEB1

**July 26, 2007**

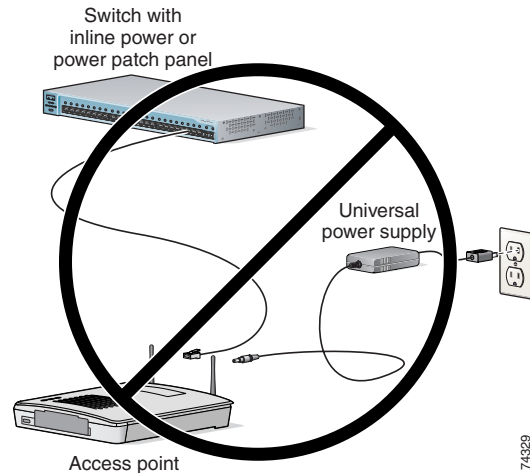
**Figure 2** *Improper Power Configuration Using Two Power Sources*

You cannot provide redundant power to 1100 and 1200 series access points with both DC power to its power port and inline power from a patch panel or powered switch to the access point Ethernet port. If you apply power to the access point from both sources, the switch or power patch panel might shut down the port to which the access point is connected. [Figure 2](#) shows the power configuration that can shut down the port on the patch panel or powered switch.
